GEOLOGICAL SURVEY OF ALABAMA

EVALUATION OF SEDIMENTATION RISK AND HABITAT THREAT SEVERITY FOR STREAM CROSSINGS AND CRITICAL HABITAT IN THE NORTH RIVER STRATEGIC HABITAT UNIT, ALABAMA

VOLUME 1: REPORT

Open-File Report 1502

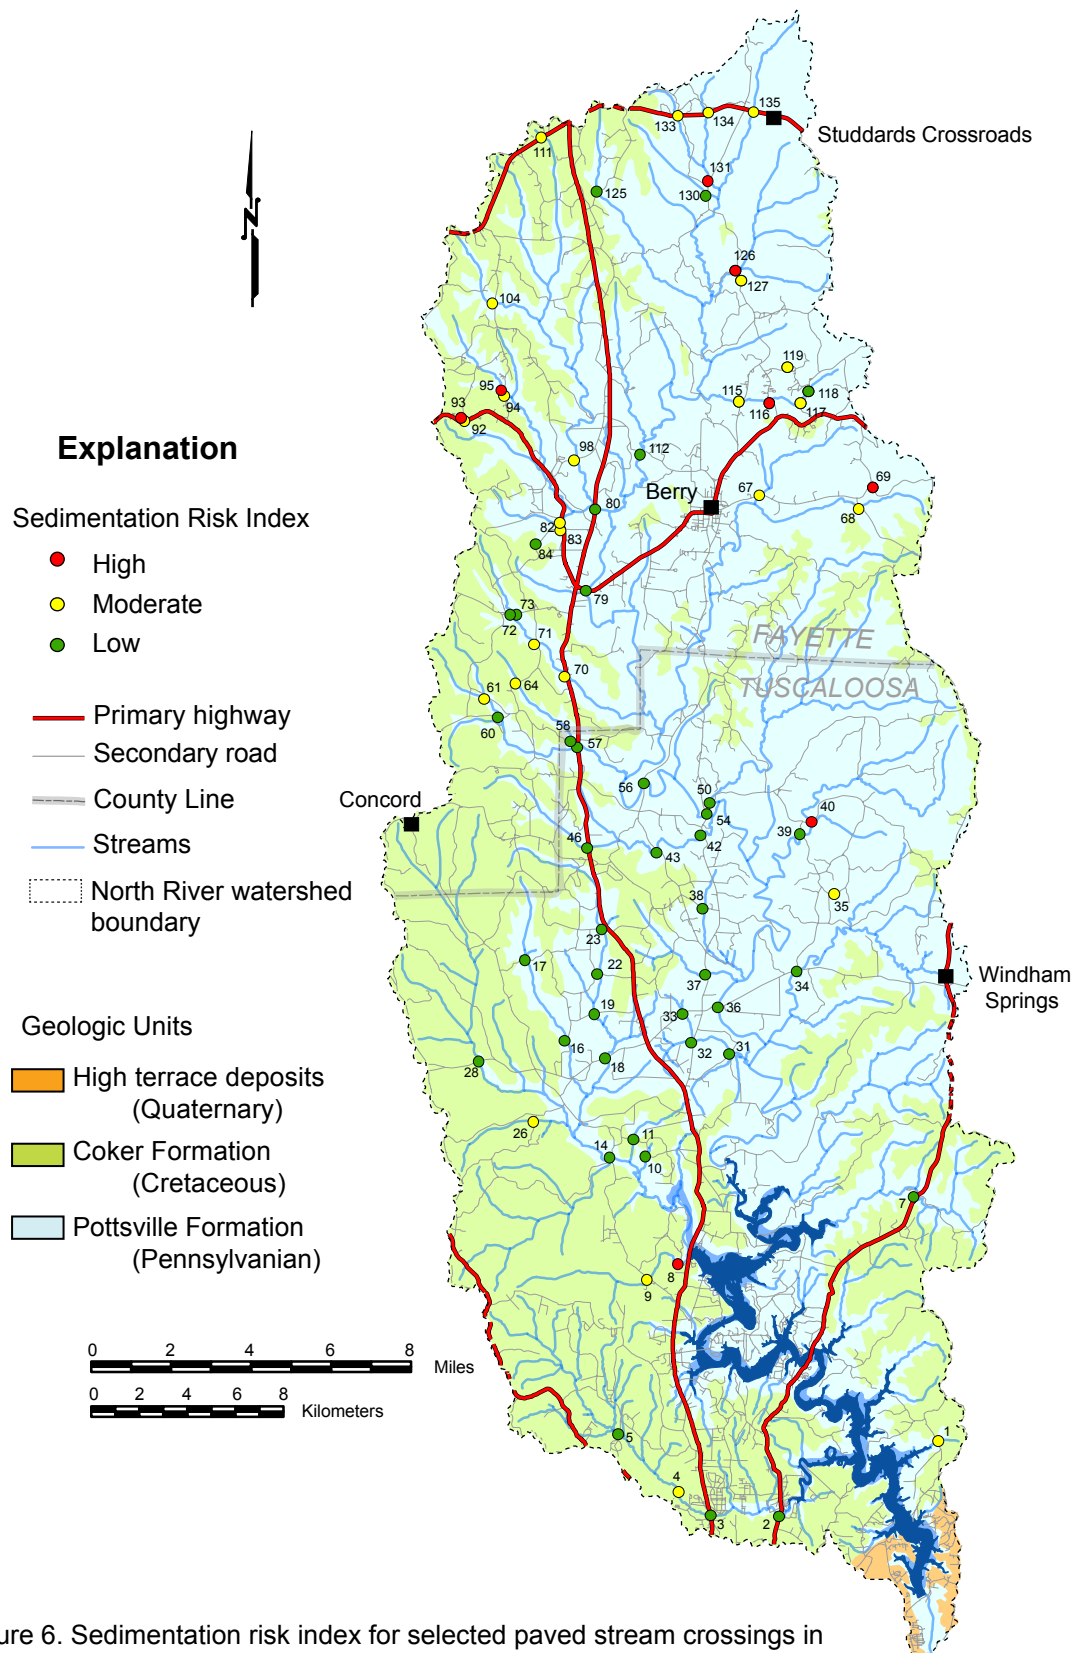
Figure 6. Sedimentation risk index for selected paved stream crossings in Fayette and Tuscaloosa Counties.

Paved crossings also had sedimentation issues. For the eight paved sites that scored high risk for sedimentation, bridge fill condition and condition of the inlet/outlet

structure generally scored poorly, as well as upstream and downstream channel morphology and alteration of the downstream channel and banks.

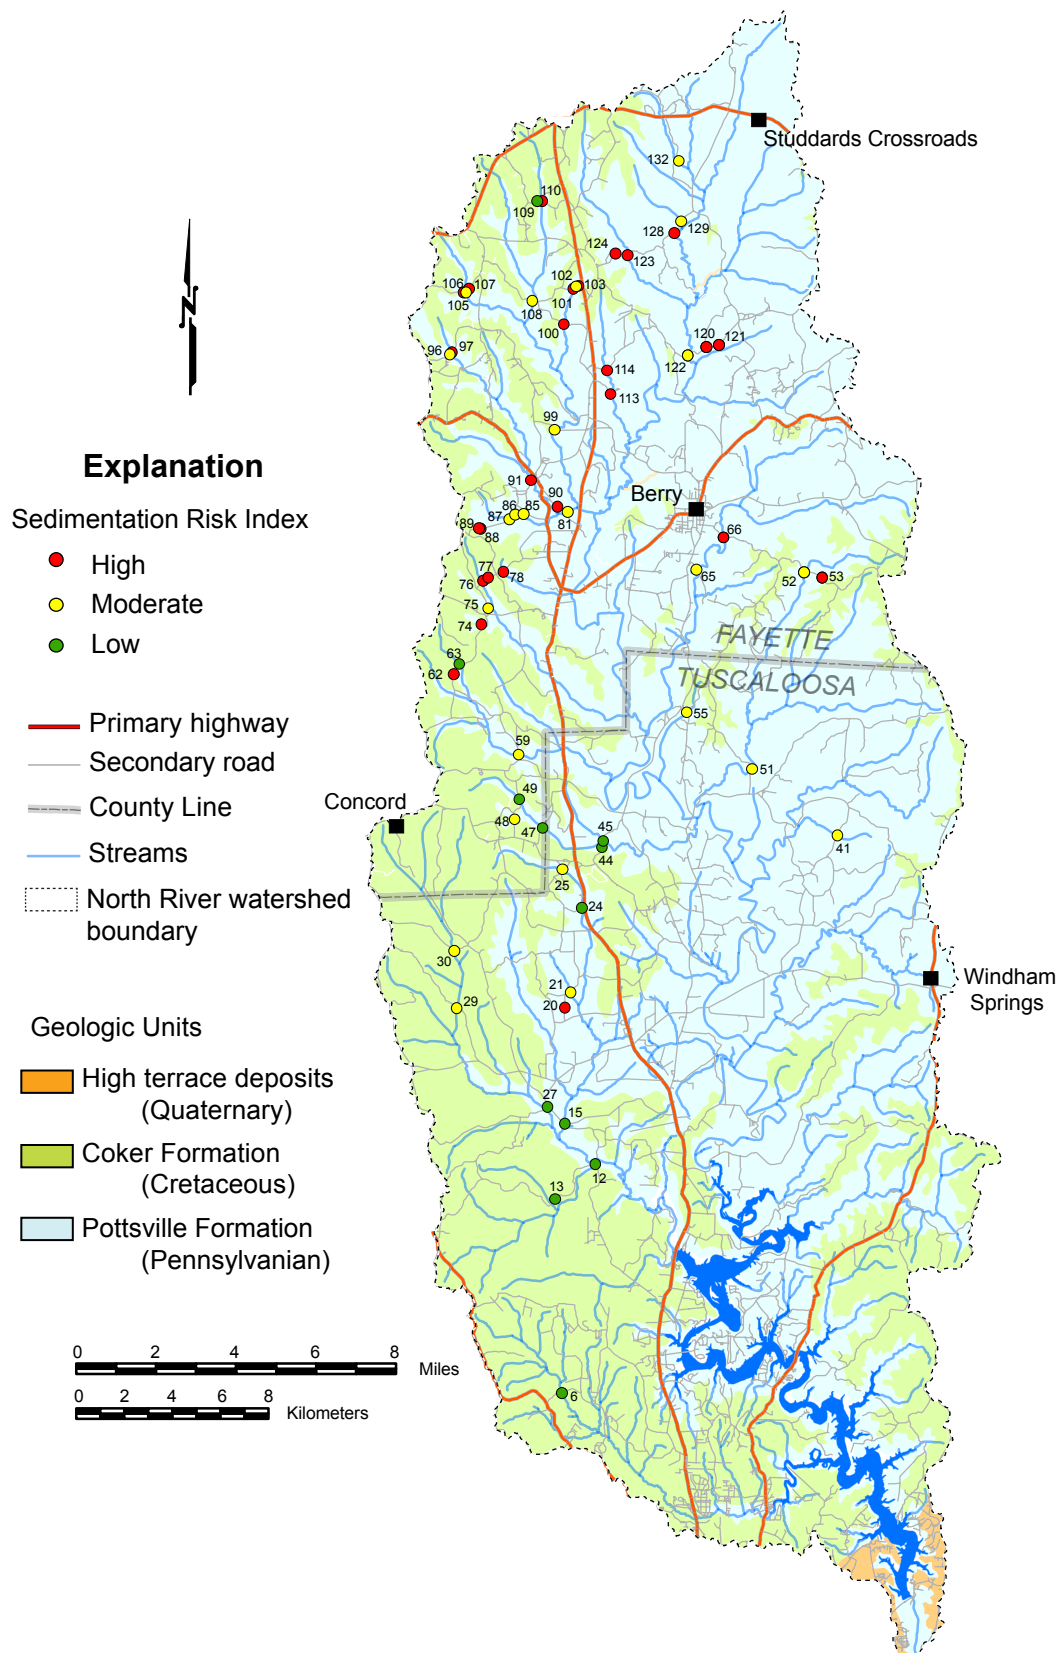
Figure 7. Sedimentation risk index for selected unpaved stream crossings in Fayette and Tuscaloosa Counties.

Unpaved roads generally presented a higher risk of instream sedimentation effects compared to paved roads (figs. 9, 10). The unpaved road prism was generally composed predominantly of native aggregate (gravel) mixed with some sand, which in most instances was a stable paving material with less tendency to migrate into streams (compared to roads and crossings dominated by a sand or sandy loam prism). Sedimentation issues identified for unpaved roads were related to the engineered ditches and their outlets to the stream and the poor condition of the bridge fill material. Crossing fill material that was not properly stabilized was a significant source of sediment at several sites, bare soil and/or unprotected ditches were also sources of sediment in addition to that eroded from poorly constructed/bare soil ditch outlets.

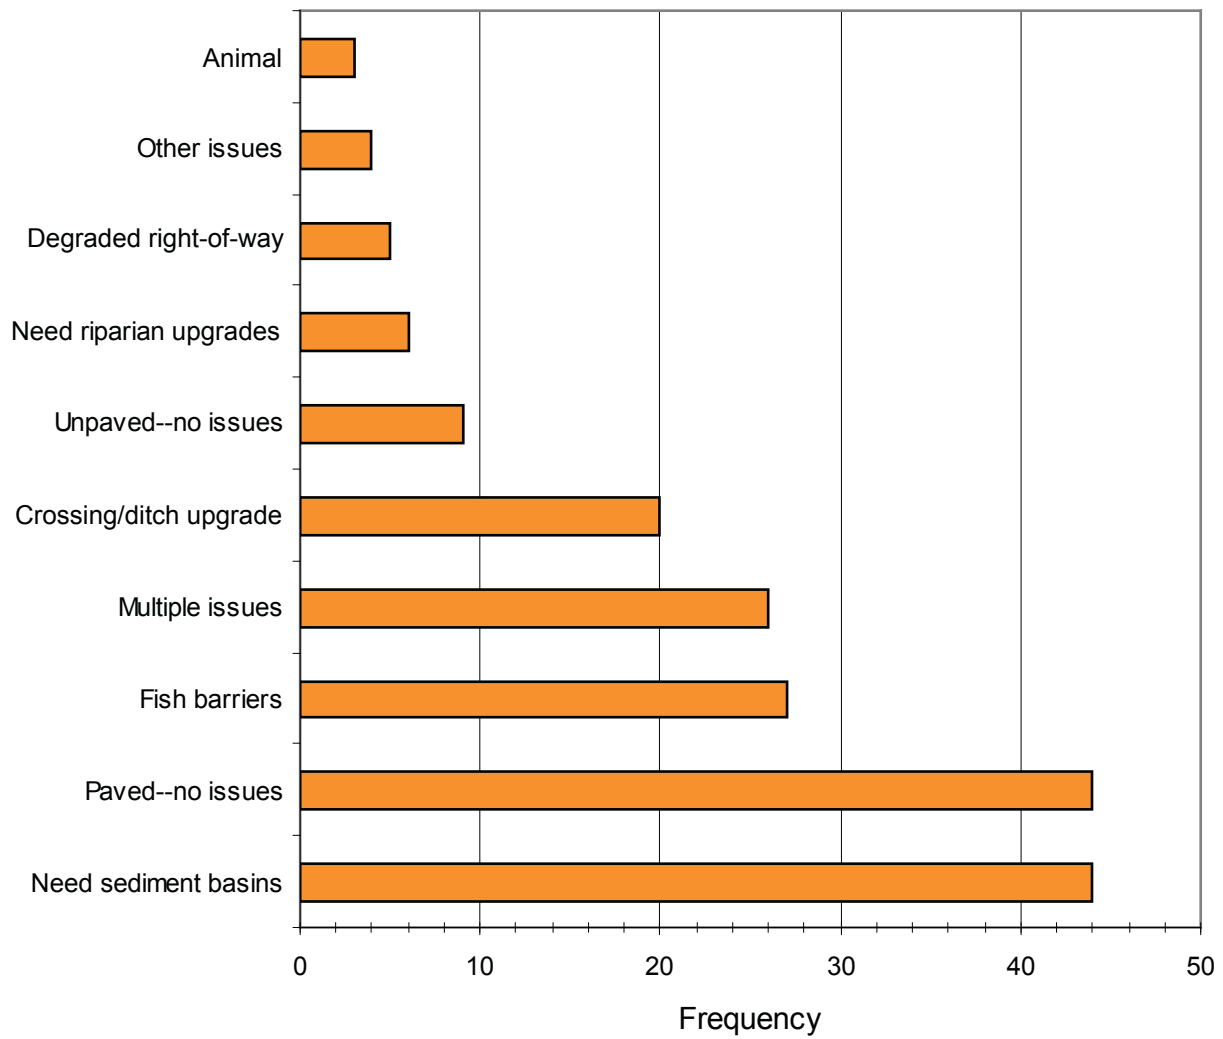
Figure 11. Habitat and sedimentation risk issues and recommended improvements for selected stream crossings in Fayette and Tuscaloosa Counties.

The issues and recommended improvements identified during this investigation are presented for each site in appendix C and summarized in figure 11. The most frequently recommended improvement (44 sites) is the installation of small retention basins in ditches near the outlets to trap sediment before it drains into the stream. These basins can be constructed of riprap, or other rubble-sized material, or can simply be a constructed depression deep enough to capture the heavier sediment particles. The most frequently observed issue at the 27 SRI sites was fish migration barriers. Movements of fishes up and downstream can be restricted by culverts that are perched above the water surface during low flow times of the year and by culvert openings that are blocked by debris and snags.

Stream crossing and ditch upgrades are needed at 20 sites represented by crushed corrugated pipe ends, improperly sized pipes, pipes set at extreme angles causing sedimentation, eroding bridge fill material, bare soil ditches, and bare soil outlets. Six sites needed restoration of riparian vegetation up and(or) downstream of the crossing. Five state/county highway right-of-ways needed additional erosion control and better vegetative cover. Three sites had substantial bank damage from domestic animals. Twenty-six sites had multiple issues related to sedimentation risk, and four sites had other issues including filling of a lake, the bridge structure causing geomorphic changes to the downstream channel, and unstable banks on road approaches (appendix C).

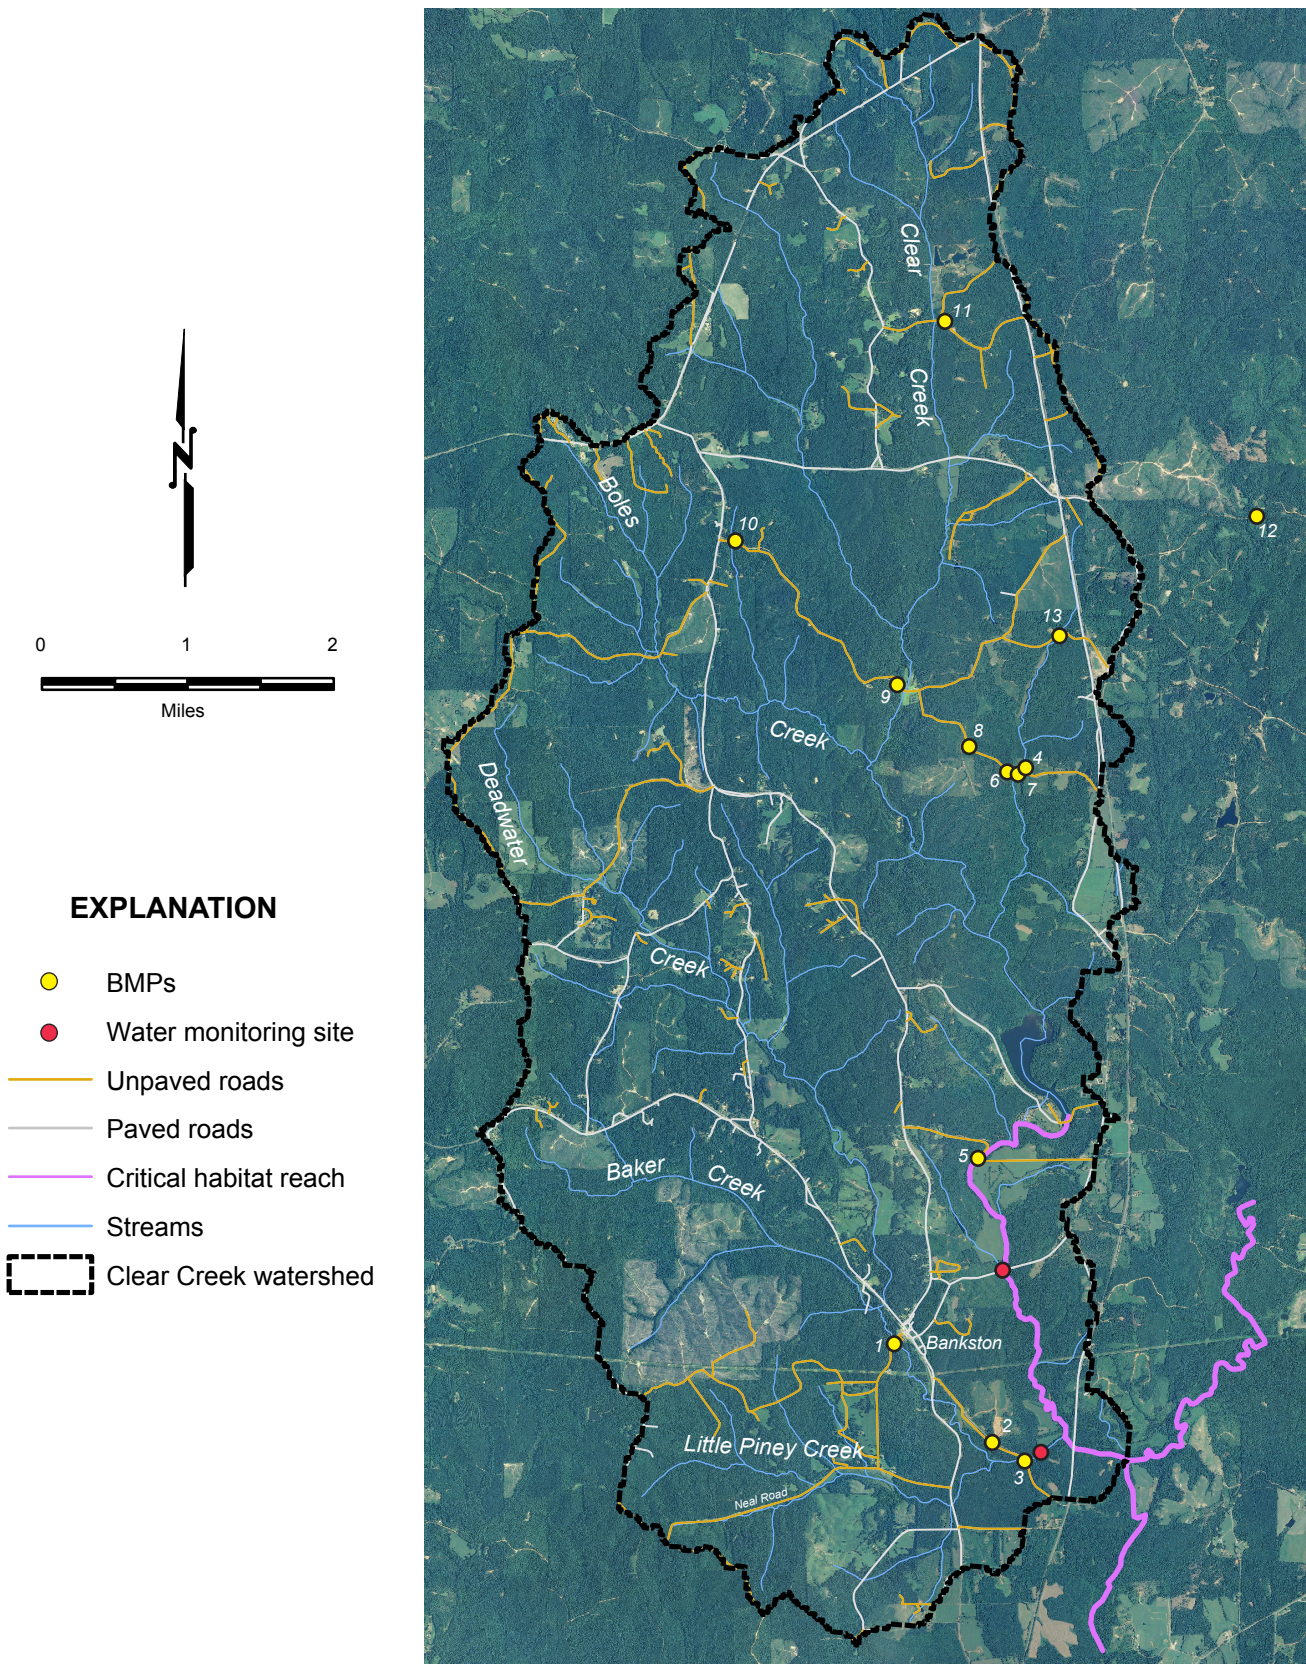
Figure 13. Location of sediment control practices in the Clear Creek watershed.

Check dam BMPs have been installed at 12 sites in the Clear Creek watershed and one site just east of Clear Creek in Fayette County (fig. 13, table 8, appendix C). Quantities of sediment have varied from location to location (tab. 8) based on the size of the impoundment, the length of road or area draining to the impoundment, and the slope of the road leading to the impoundment. Average volume of sediment captured per month varied from 0.069 yd³ at site 13 to 0.421 yd³ at site 9 with the range of capture rates relatively equal for practices of 6-month and 13-month duration (fig. 14). The useful life (time to fill) sediment basins ranged from 10 months to 8 years with a median of 2.4 years and was determined by monthly filling rate and capacity. The first sedimentation basins were installed in November of 2011, and some of those impoundments are close to their useful capacity.
