High Definition Stream Surveys of Choccolocco and Cheaha Creeks, AL 2015

February 2016

Brett Connell and James Parham, Ph.D.

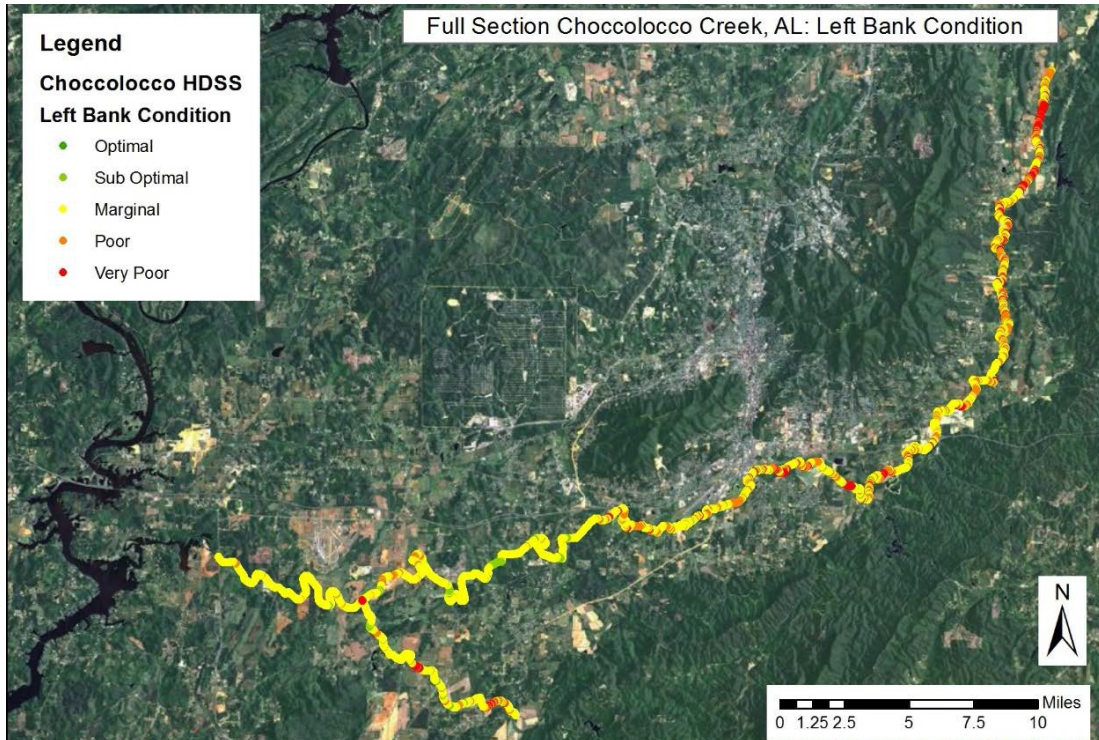
Figure 9: Choccolocco Creek Left Bank Condition Scores.

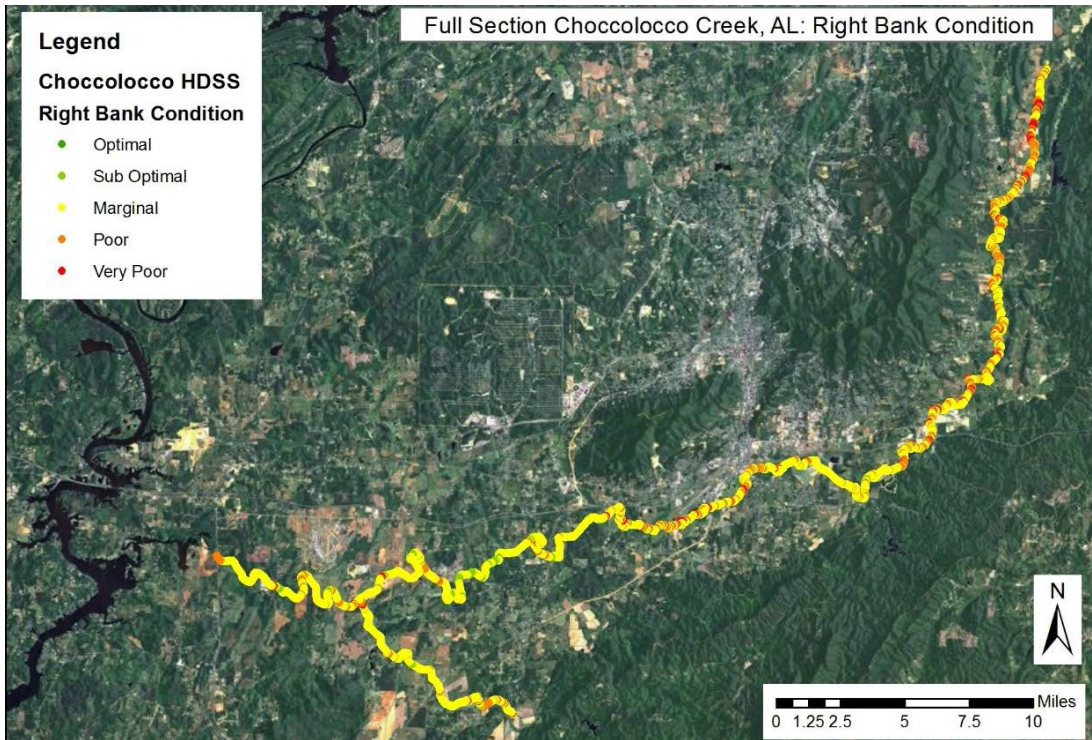
Figure 10: Choccolocco Creek Right Bank Condition Scores.

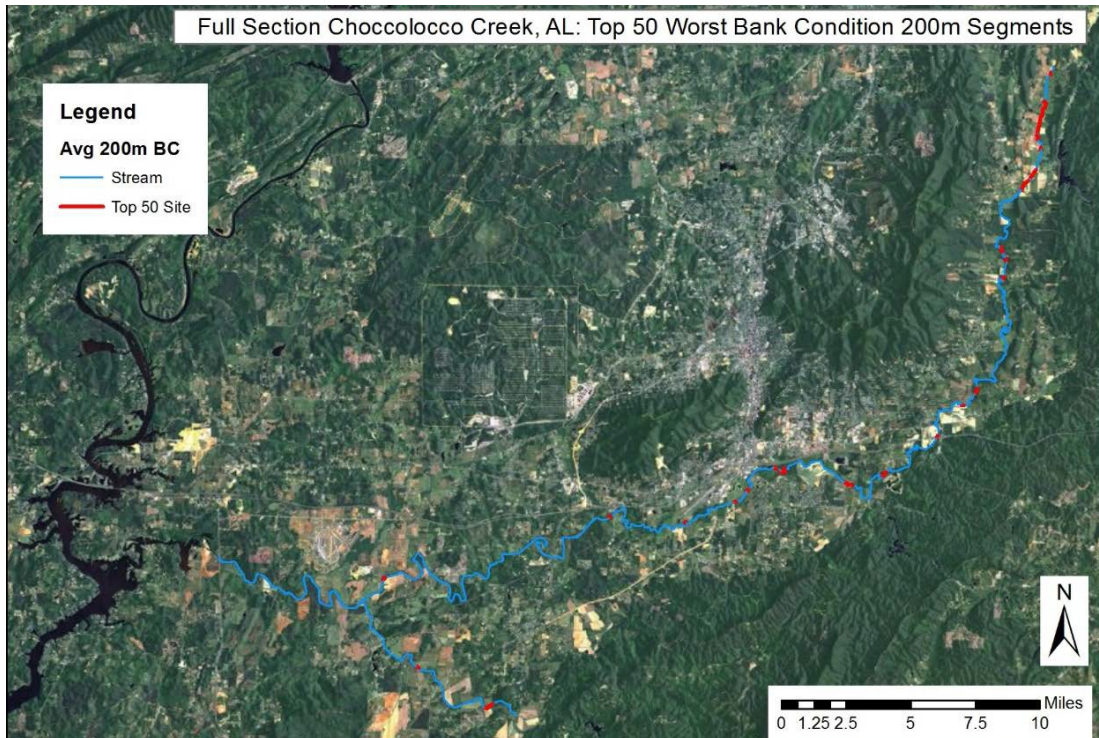
To better understand the spatial distribution of bank condition scores and to rank areas with respect to their bank conditions, additional analysis was performed. The overall survey area was divided into sections of approximately 200 meters. Then combination scores (left + right bank condition score/) were averaged for each 200 m section. For example, if the left bank condition score was Level 1 (Optimal Condition) and the right bank was Level 3 (Fair Condition), the combination score for that section was Level 2 (Good Condition). From the site ranking analysis, a total of 656 segments were created and ranked from optimal to very poor condition. For visualization purposes, the top 50 worst 200 meter survey segments with the lowest bank conditions scores were mapped (Figure 15).

Figure 15: Choccolocco Creek locations of top 50 worst 200 m reaches.

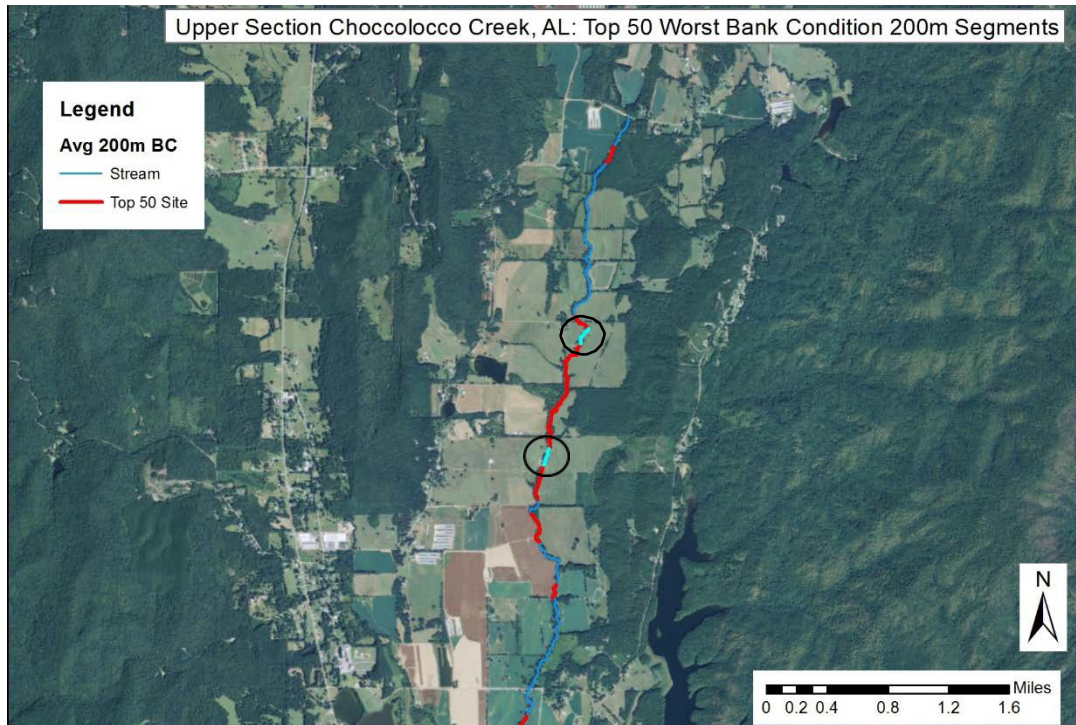
Figure 16: Choccolocco Creek with the worst 200 m reaches being highlighted.

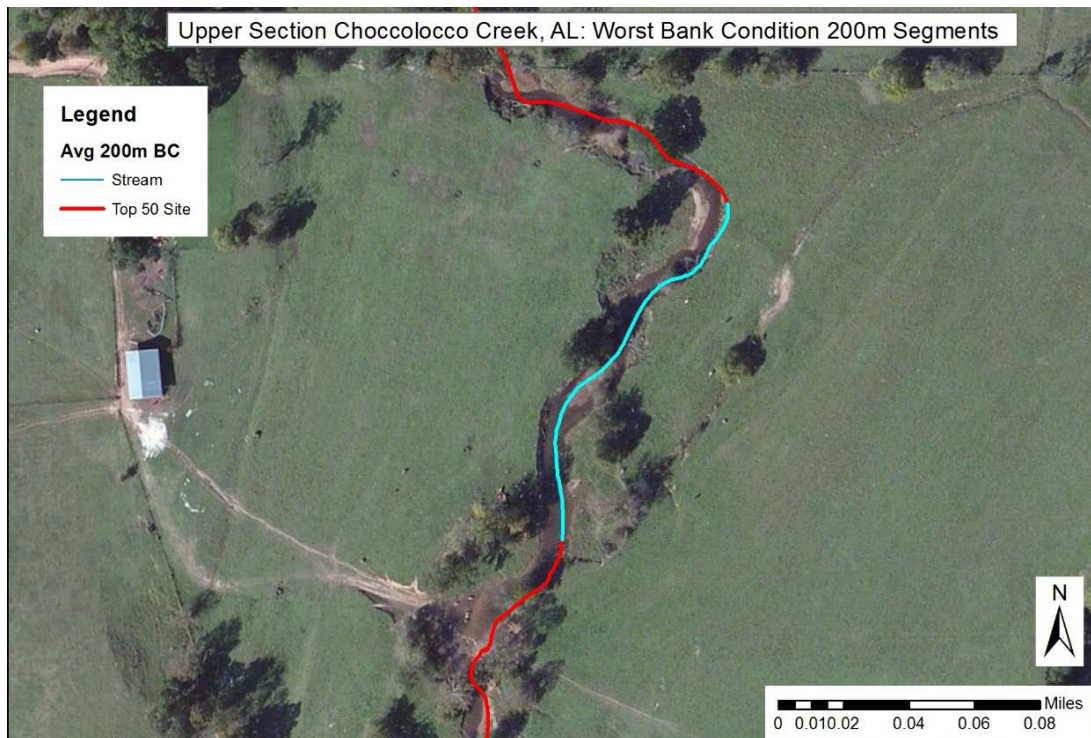
Figure 17: Segment 15, one of two worst locations in the Choccolocco Creek Survey. This site begins at N -85.66378 and W 33.77287.

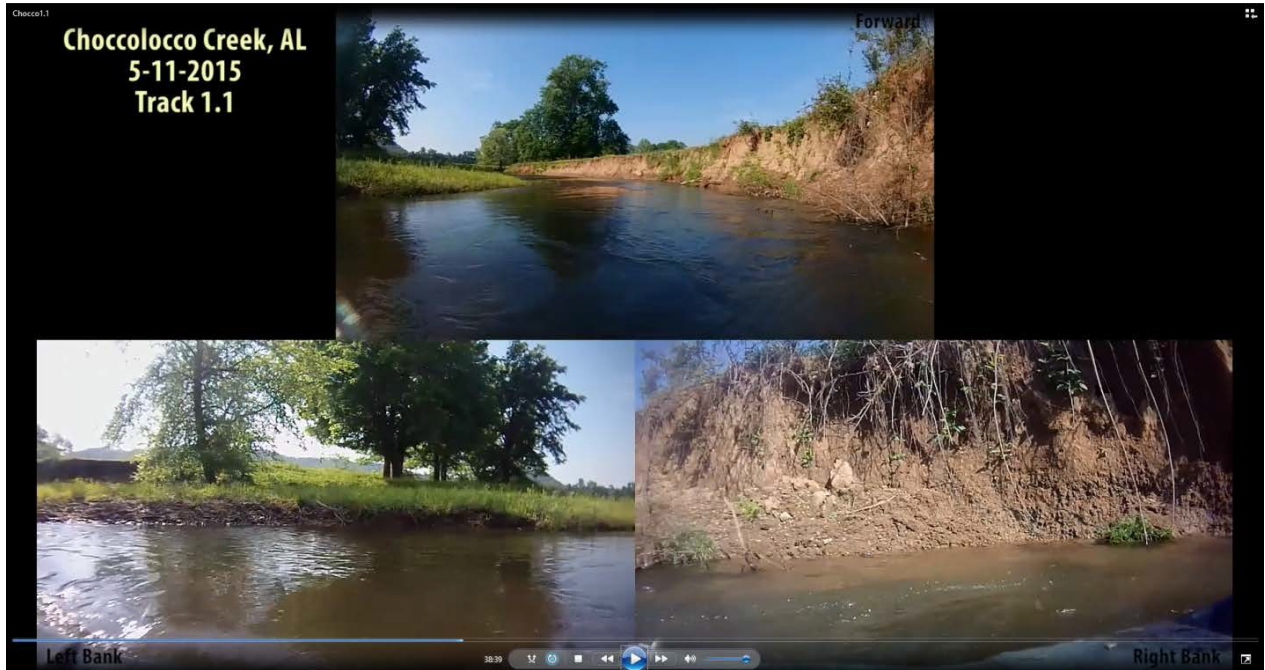
segment 15 (Figure 16 Figure 18) and segment 23 (Figure 19Figure 20), were tied for the lowest bank condition score during the survey and each segment had very poor overall scores. Both of these sites were located in the upper survey section. When looking more closely at each site from both the aerial imagery and HDSS video for Segment 15 and Segment 23, it was apparent that stream degradation was caused by allowing cattle direct access to the stream (Figure 20).

Figure 18: HDSS video imagery for Segment 15, one of two worst locations in the Choccolocco Creek Survey. Note the large failing stream bank and lack of riparian vegetation.

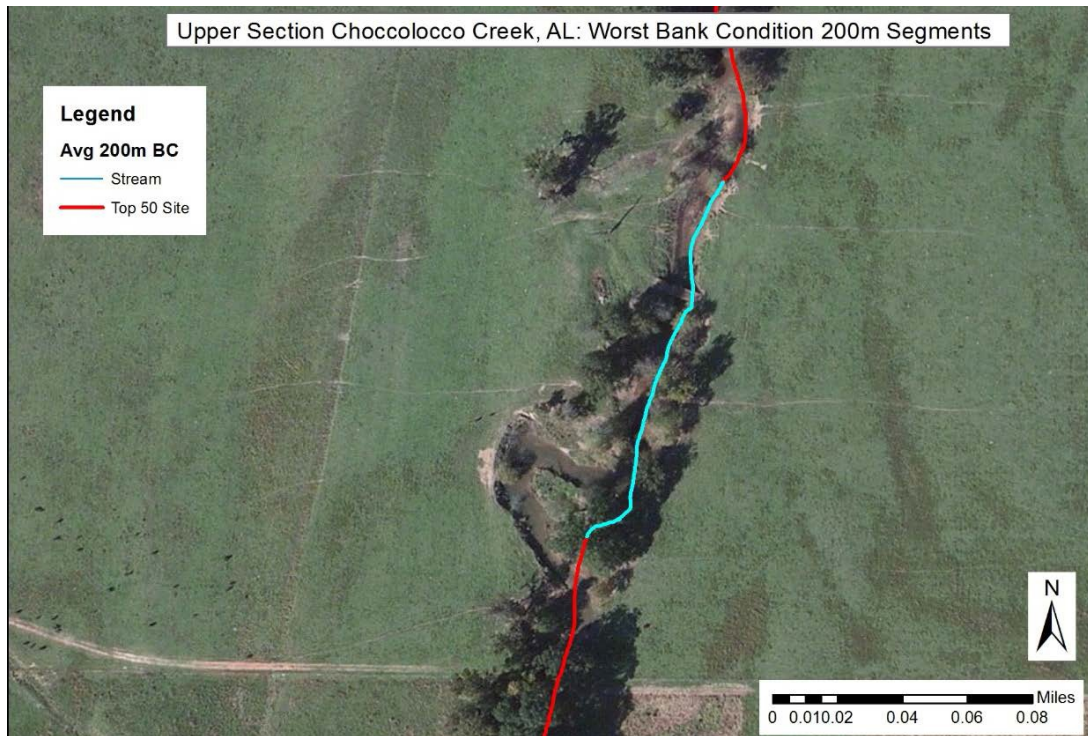
Figure 19: Segment 23, one of two worst locations in the Choccolocco Creek Survey. The site begins at N -85.66753 and W 33.76340.

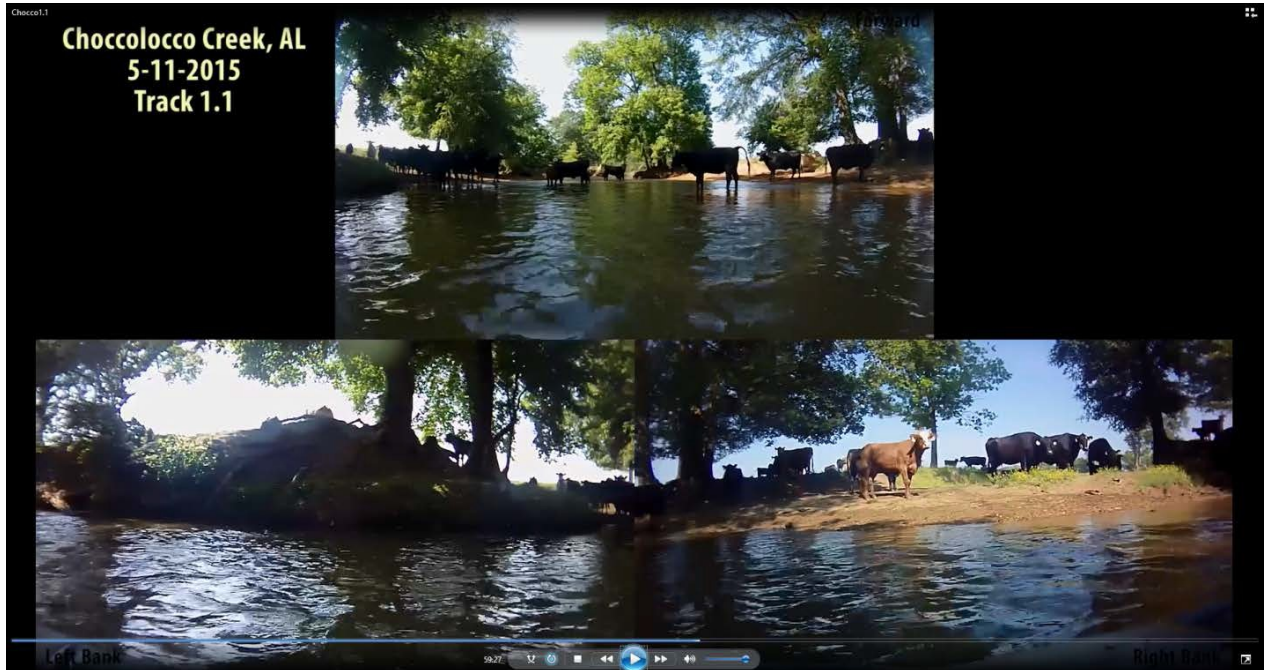
Figure 20: HDSS video imagery for Segment 23, one of two worst locations in the Choccolocco Creek Survey. Note the cows present in the stream during the survey.
