Choccolocco Creek Watershed Stream Crossing Report

Prepared – *July 2019* – by:

LGL Limited
9768 Second Street
Sidney, British Columbia V8L 3Y8

MacDonald Environmental Sciences Ltd.
Pacific Environmental Research Centre
#24 - 4800 Island Highway North
Nanaimo, British Columbia V9T 1W6

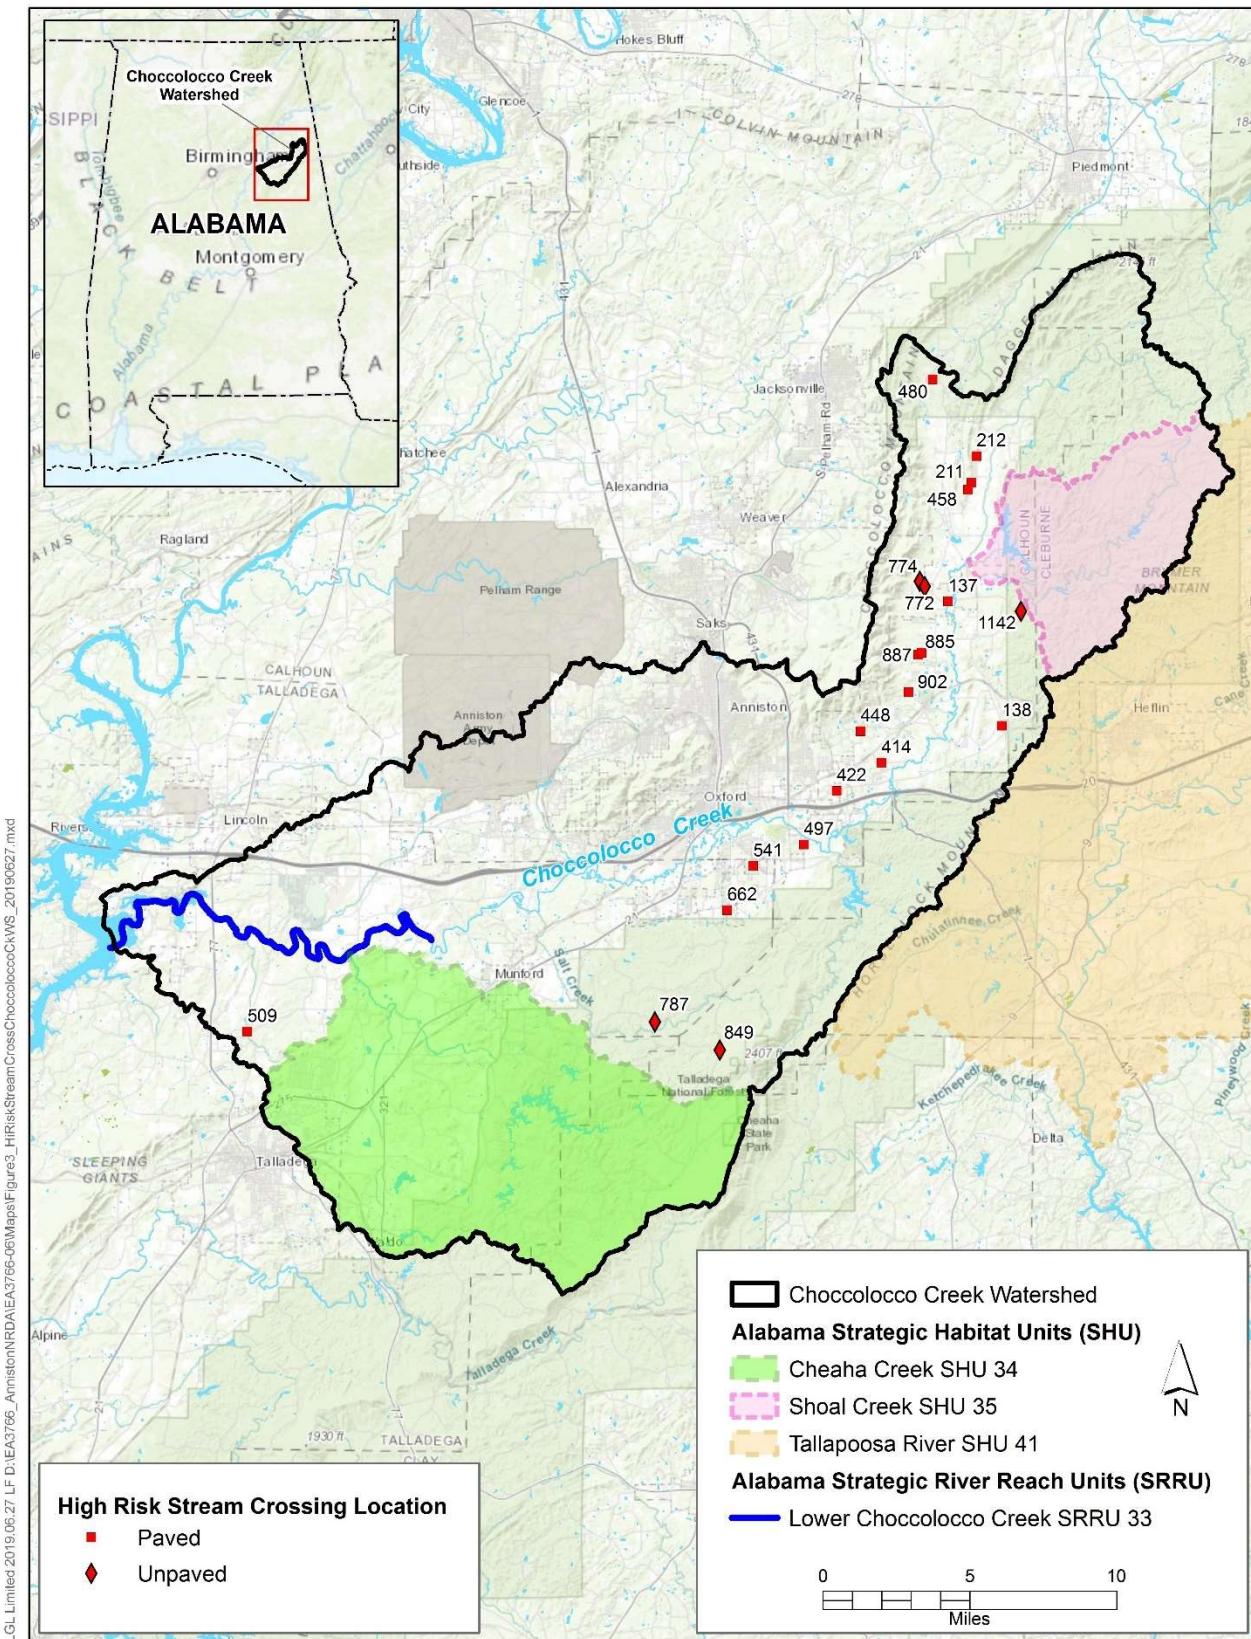
Figure 3. Locations of high-risk stream crossings.

A total of 21 (5%) stream crossings were rated as high risk, 119 (27%) were rated as moderate risk, and 303 (68%) were rated as low risk. None of the high-risk stream crossings were in a SHU or SRRU (Table 3; Figure 3). All high-risk stream crossing structures were culverts. The most common sedimentation risks identified at high-risk stream crossings were poor channel morphology upstream and downstream of the crossing, alteration of the channel downstream of the crossing, highly skewed culvert angle ($>30^\circ$), poor fill condition, and ditches of bare soil or concrete (Table 3). Other sedimentation risks identified at several crossings were blocked culverts, high potential eroded sediment volume, and steep road approach slope.

The 21 stream crossings rated as high risk (Table 3; Figure 3) and the seven stream crossings rated as moderate risk in a SHU or SRRU (Table 5; Figure 4) should be identified as priorities for restoration activities within the Choccolocco Creek watershed. The high-risk stream crossings are threatening aquatic habitat and water quality at a number of locations within the Choccolocco Creek Watershed. Moderate risk stream crossings may be having a significant impact on the critical habitat of sensitive species found in the Lower Choccolocco Creek SRRU, the Shoal Creek SHU, and/or the Cheaha Creek SHU.

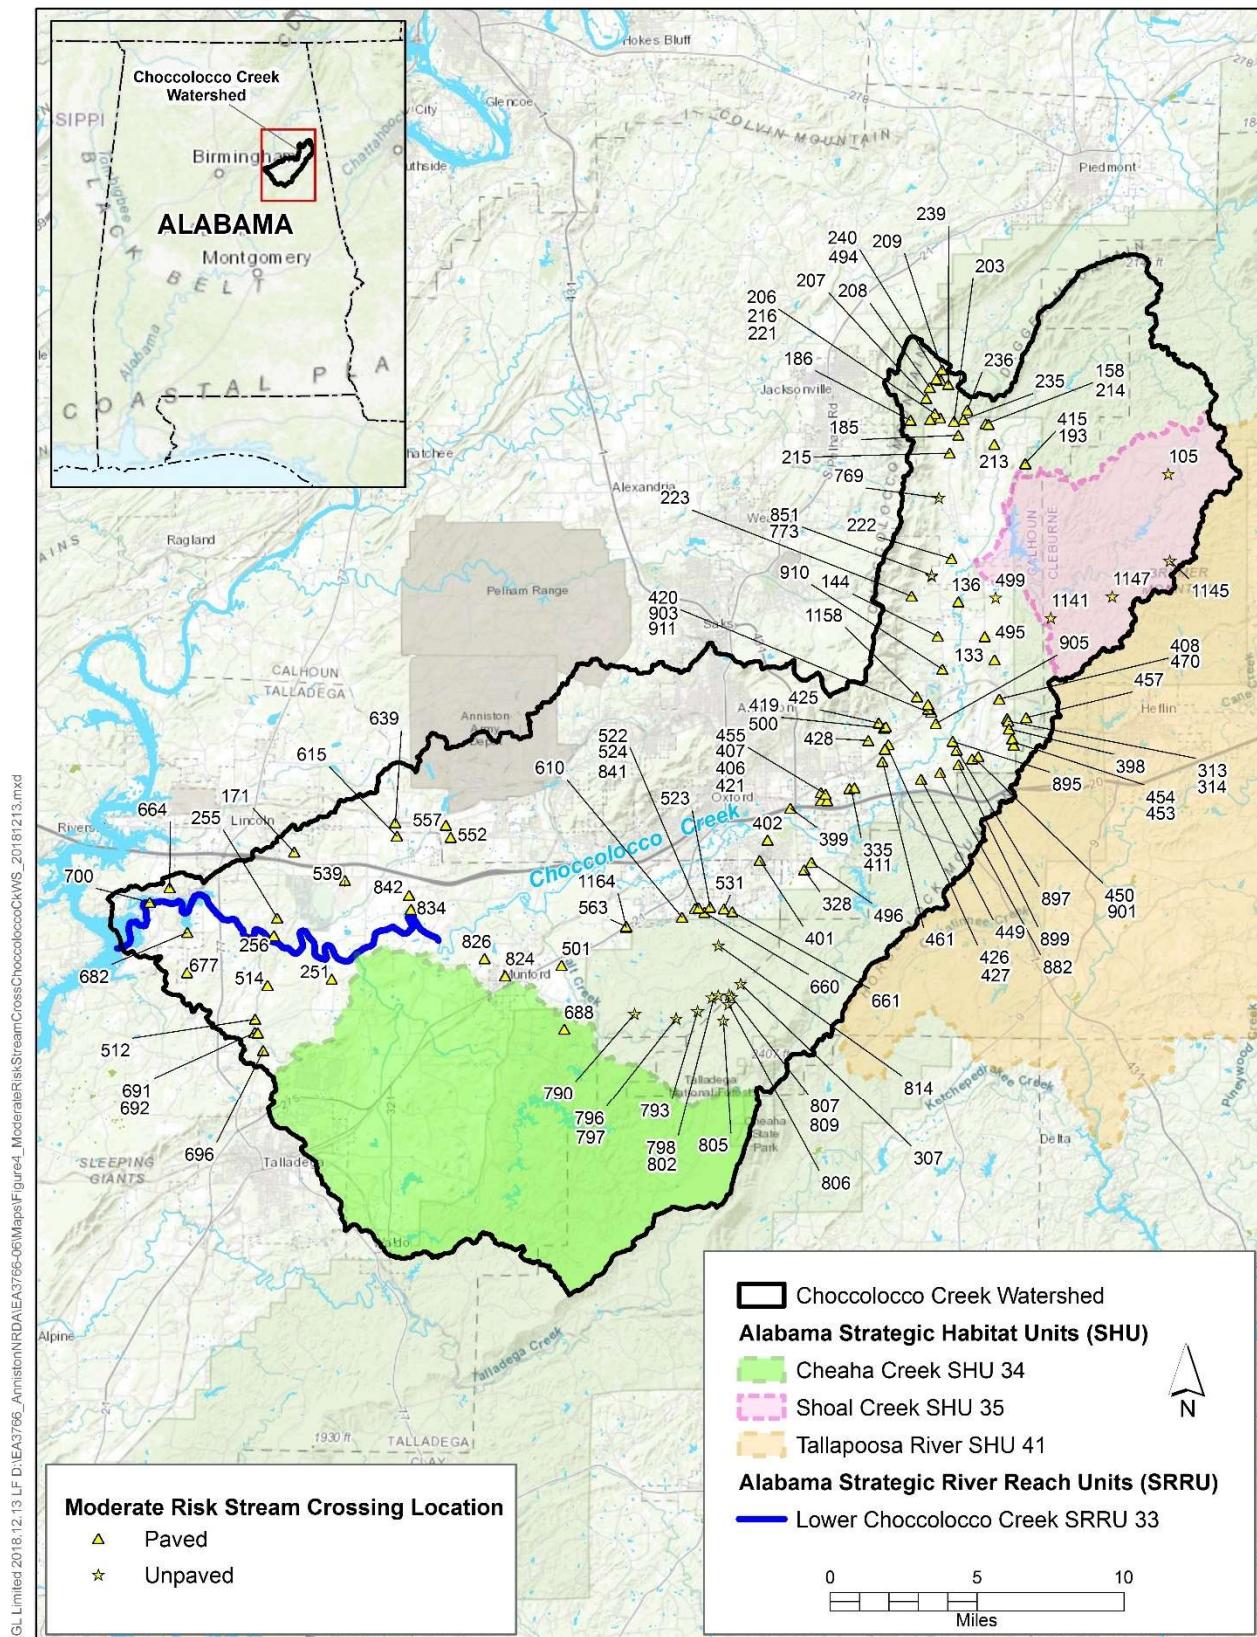
Figure 4. Locations of moderate-risk stream crossings.

A total of 119 of the stream crossings were rated as posing moderate risk of sedimentation (Table 4; Figure 4). Of these moderate risk stream crossings, seven were located within a SRRU or SHU (Table 5). The seven moderate-risk stream crossings in a SRRU or SHU were all culverts. The most common sedimentation risks at the moderate risk sites were poor channel morphology upstream and downstream of the crossing, alteration of the channel downstream of the crossing, culverts that were blocked or exhibited scouring and sediment islands, and road approach ditches of bare soil or concrete (Table 5).

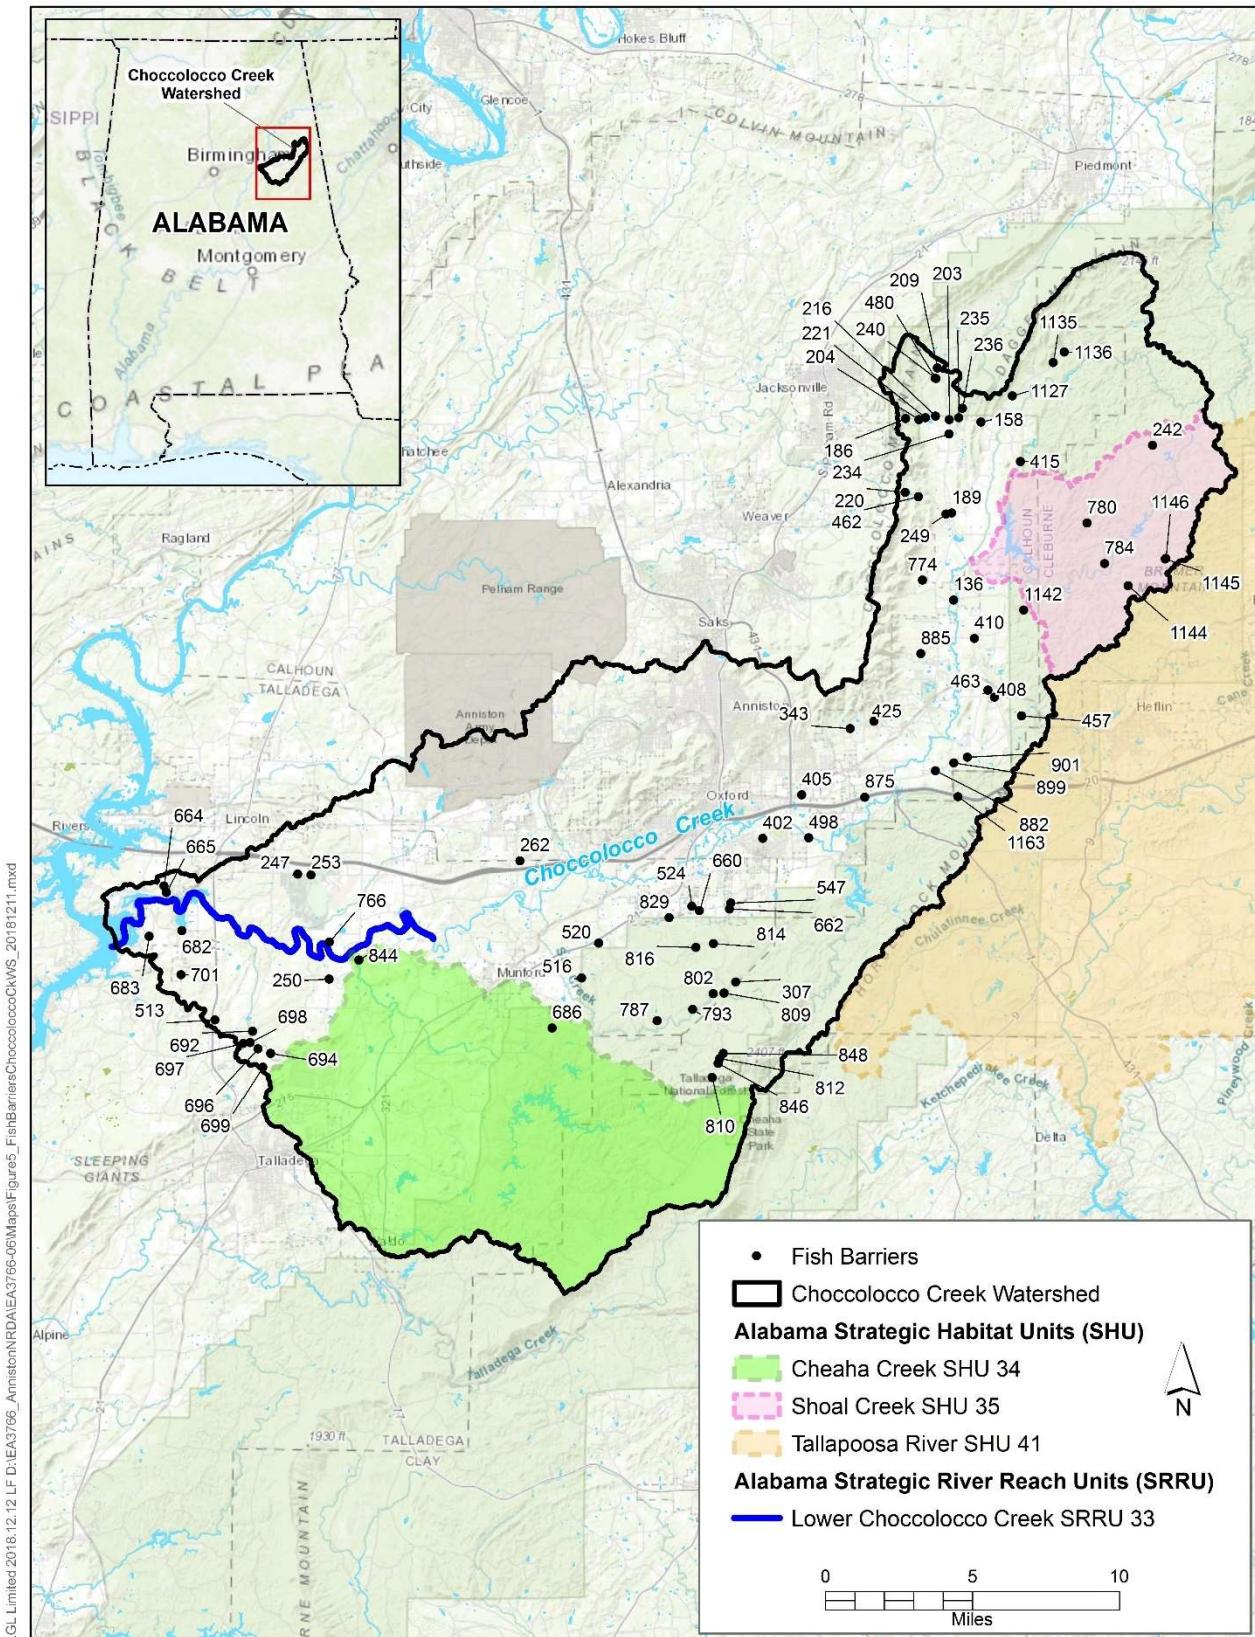
Figure 5. Stream crossings with fish barriers.

Barriers to fish passage were identified at 81 stream crossings (Table 6; Figure 5). Of these locations, six were in the Shoal Creek SHU, two were in the Cheaha SHU, and one was in the Lower Choccolocco Creek SRRU (Table 7). Fish barriers are particularly concerning in the Lower Choccolocco Creek SRRU and Shoal Creek SHU that provide critical habitat for the Blue Shiner. Habitat fragmentation has already constrained the Blue Shiner to small isolated populations that are vulnerable to habitat degradation and reduced genetic diversity (USFWS 2015). Fish barriers also threaten the sensitive mussel species in the SHUs and SRRU, as they require fish to host and disperse their larvae (Watters 1999).

The majority (86%) of stream crossings identified as fish barriers had perched culverts with outfall drop heights from 0.16 to 6.00 ft (Table 6). The stream crossings with the most severe outfall drops ($\geq 75^{\text{th}}$ percentile of outfall drop values) are listed in Table 8 and presented in Figure 6. Perched culverts reduce stream connectivity in watersheds by preventing aquatic organisms from entering the culvert and accessing the habitat available in upstream areas. Culverts also reduce habitat connectivity when they fill with debris and become blocked. Blocked culverts were noted at 13 (16%) of the stream crossings identified as fish barriers (Table 6). Large culvert skew angles ($>30^{\circ}$) were measured at 20 (25%) of the stream crossings identified as fish barriers. Misaligned culverts straighten the natural channel and increase water velocity, which can make the culvert impassable for some aquatic organisms, particularly small-bodied fish with low maximum swimming speeds (Bates *et al.* 2003).

The fish barriers identified at crossings in the Lower Choccolocco Creek SRRU and the SHUs (Table 7; Figure 5) should also be identified as restoration priorities to maintain connectivity where critical habitat for priority species has been identified. Additionally, the stream crossings with the highest outfall drops (Table 8; Figure 6) should be prioritized to improve stream connectivity within the Choccolocco Creek Watershed. Sites with fish barriers should be re-visited to conduct fish habitat assessments to further refine a list of priority stream crossings.

Culvert modifications can improve fish passage where the outfall drops are not severe. Weirs made of rocks installed downstream of the culvert can raise the tailwater elevation and back-flood the culvert outlet to reduce water velocity and improve fish access (Chilibeck, *et al.* 1993). Weirs should be constructed within 1.5 to 2 channel widths downstream of the outlet (BC MFLNRO *et al.* 2012). Gaps need to be provided between the weir boulders to maintain fish passage (BC MFLNRO *et al.* 2012). Biologists and engineers should be consulted prior to installing any crossing modification to ensure the modification is appropriate for the crossing structure and fish passage is not further impaired (BC MFLNRO *et al.* 2012).

Some fish barriers will likely require culvert replacement. The culverts should be imbedded within the stream channel to a depth of 40% of the culvert diameter and a downstream weir should be installed to prevent the new culvert from becoming perched (BC MFLNRO *et al.* 2012). Large material should be placed inside the culvert to retain the substrate (BC MFLNRO *et al.* 2012), or a bottomless culvert should be installed where substrate is naturally comprised of small material (i.e., fines, gravel and cobble). The culvert opening should encompass the channel width, and the bottom should be lined with natural substrate (BC MFLNRO *et al.* 2012). As crossing replacements can be expensive, fish habitat assessments will be useful to prioritize which crossing replacements to allocate resources to.

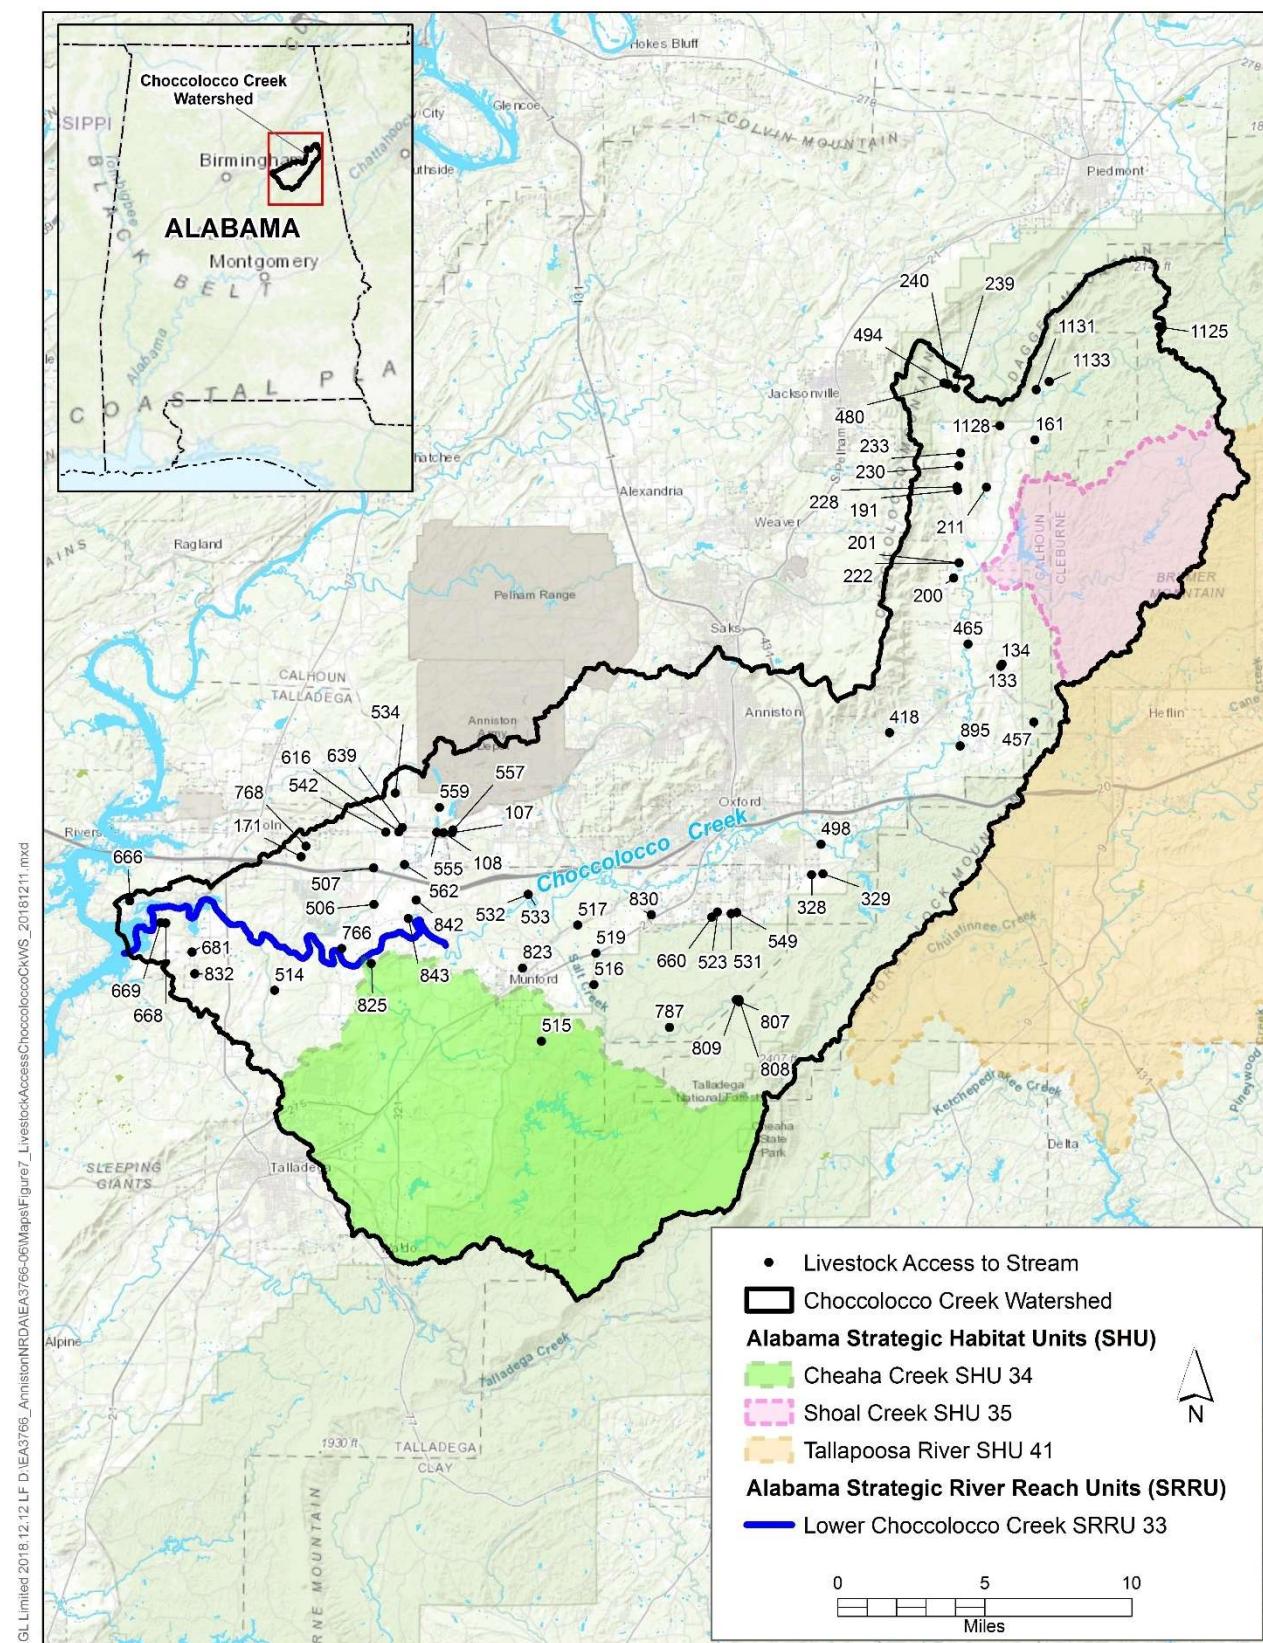
Figure 7. Stream crossings with livestock access.

Livestock had access to 66 of the assessed stream crossings (Table 9; Figure 7), including two in the Cheaha Creek SHU and one in the Lower Choccolocco Creek SRRU (Table 10). Livestock that access streams damage riparian area through soil compaction and grazing on riparian vegetation. The loss of riparian vegetation can lead to unstable streambanks

and increased runoff from adjacent fields leading to higher sedimentation and nutrient loading risks (Davies-Colley and Parkyn 2001). Livestock also threaten water quality when they defecate instream, thereby degrading water quality and promoting eutrophic conditions (Davies-Colley and Parkyn 2001). The heavy algal growth spurred by eutrophic conditions covers clean rocky substrates required by many of the sensitive species in the SHUs and SRRU. Algal respiration at night and bacterial degradation of algal biomass can deplete dissolved oxygen to concentrations that harm aquatic species (USFWS 2005; USFWS 2014). The high biological oxygen demand associated with the deposition of fecal matter can also deplete dissolved oxygen (USFWS 2005). The effects of eutrophication can inhibit the feeding, respiration, and reproduction of aquatic snails, including the threatened Painted Rocksnail, Lacy Elimia (*Elimia crenatella*), and Tulotoma Snail (*Tulotoma magnifica*) found in the Lower Choccolocco Creek SRRU (USFWS 2005). The increased water temperature and reduced light penetration caused by eutrophication have negative effects on fish behavior and reproduction (USFWS 2014). Eutrophication is believed to have contributed to the extirpation of Blue Shiner from the Cahaba River (USFWS 2014) and could threaten the populations remaining in the Lower Choccolocco Creek SRRU and Cheaha Creek SHU.

Cattle fencing should be repaired or installed where access to livestock was documented (Table 9; Figure 7). Riparian vegetation should also be restored where bare areas are present adjacent to agricultural land to reduce nutrient and sediment loadings. Priority should be given to the three crossings in the Lower Choccolocco Creek SRRU and the Cheaha Creek SHU identified to have livestock access (Table 10). Stream bank restoration will be most effective if farmers are involved in restoration activities and educated as to how they can change their practices for a sustainable riparian area. For example, farmers can provide their livestock with alternate water sources, and plan periods of grazing and rest in certain areas (Fitch *et al.* 2003).

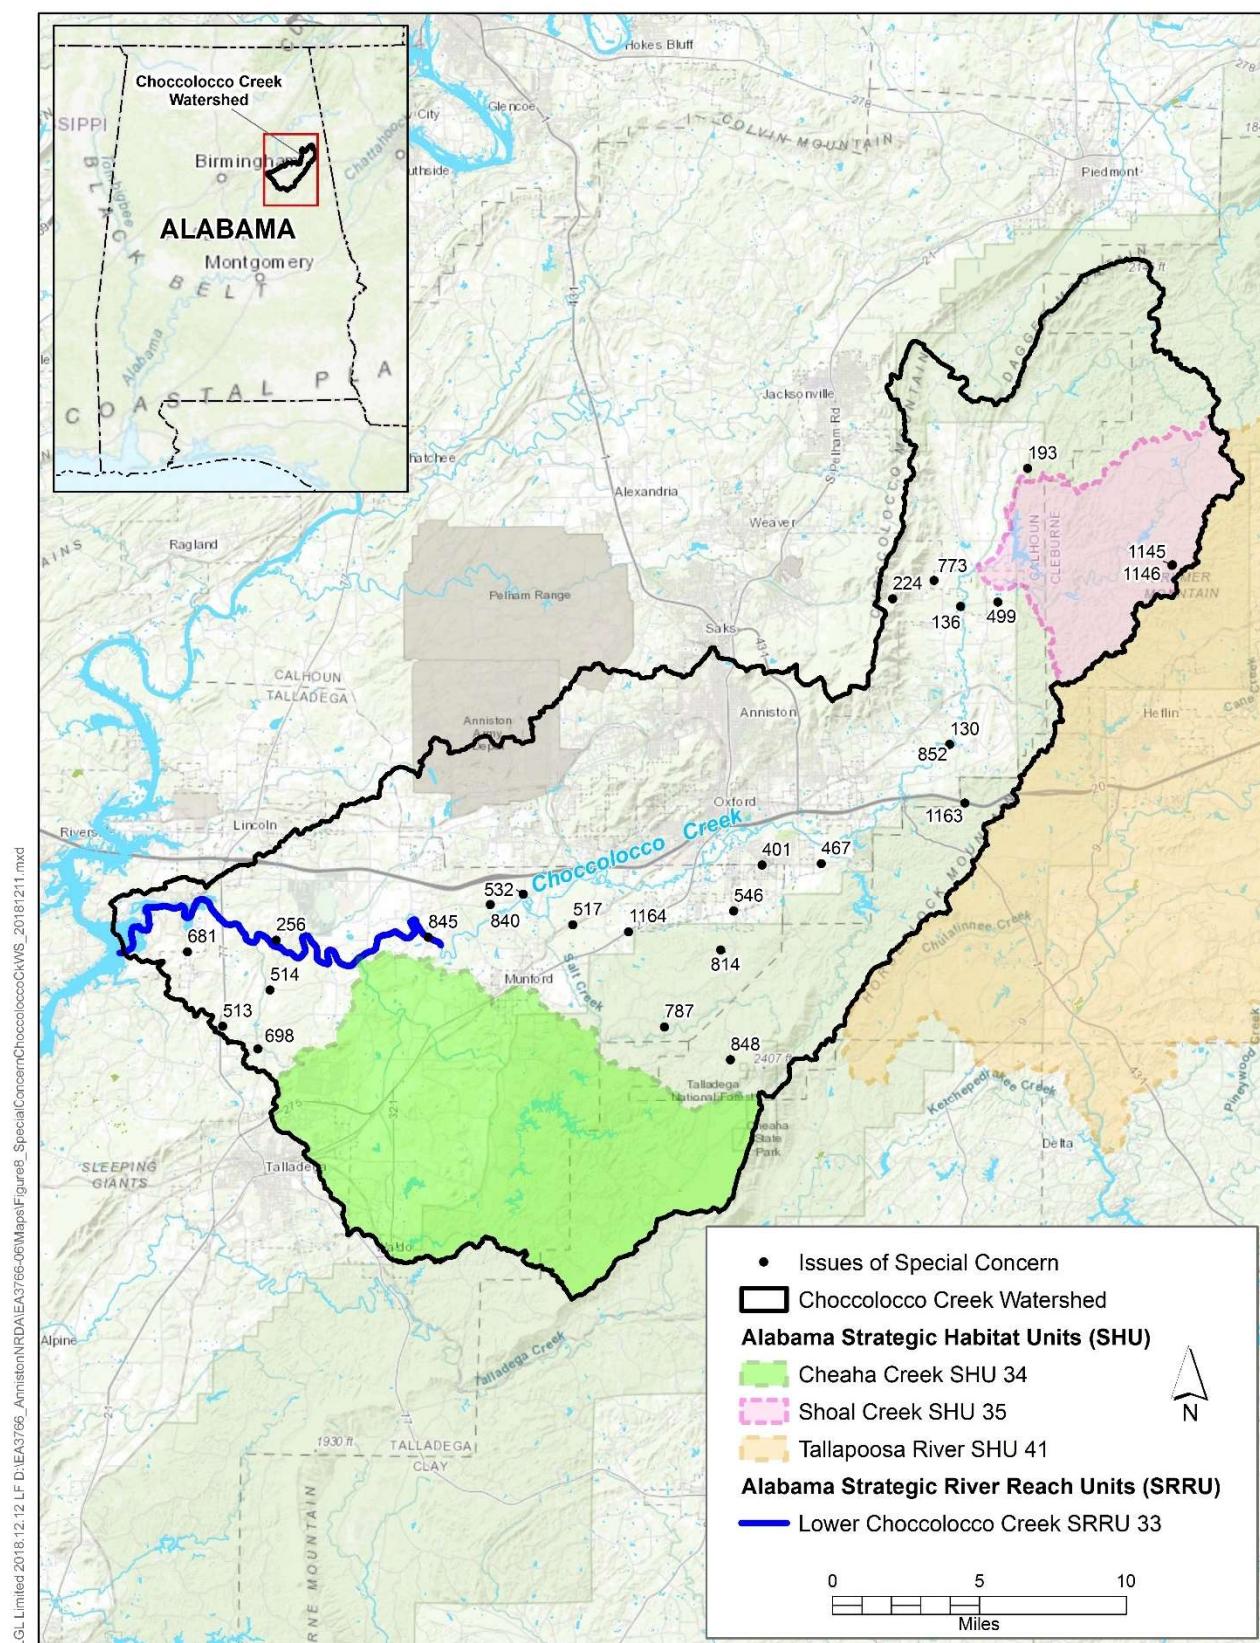
Figure 8. Stream crossings with issues of special concern.

Issues of special concern were documented at 26 stream crossings where problems outside the scope of the SRI were observed or issues require prompt attention (Table 11; Figure 8). One of these stream crossings was in the Lower Choccolocco Creek SRRU, where the issue of concern was a boat launch causing instream sedimentation. Damaged culverts were the concern at two stream crossings in the Shoal Creek SHU. One of these damaged culverts is also noted as a traffic hazard. Many of the issues of special concern related to failed crossing structures that may pose a risk to the road structure and the surrounding environment.

The concerns outside the scope of the SRI (Table 11; Figure 8) should be considered and addressed. Several stream crossings require more immediate attention, such as Crossing 517 where an investigation is required to determine the source of high turbidity, Crossing 467 where trees and debris collected behind the bridge may cause structural damage and fish passage issues, and the damaged culvert at Crossing 1145 that is a traffic hazard.
