Bear Creek BEHI Survey

Tennessee Valley Authority

19th July 2014

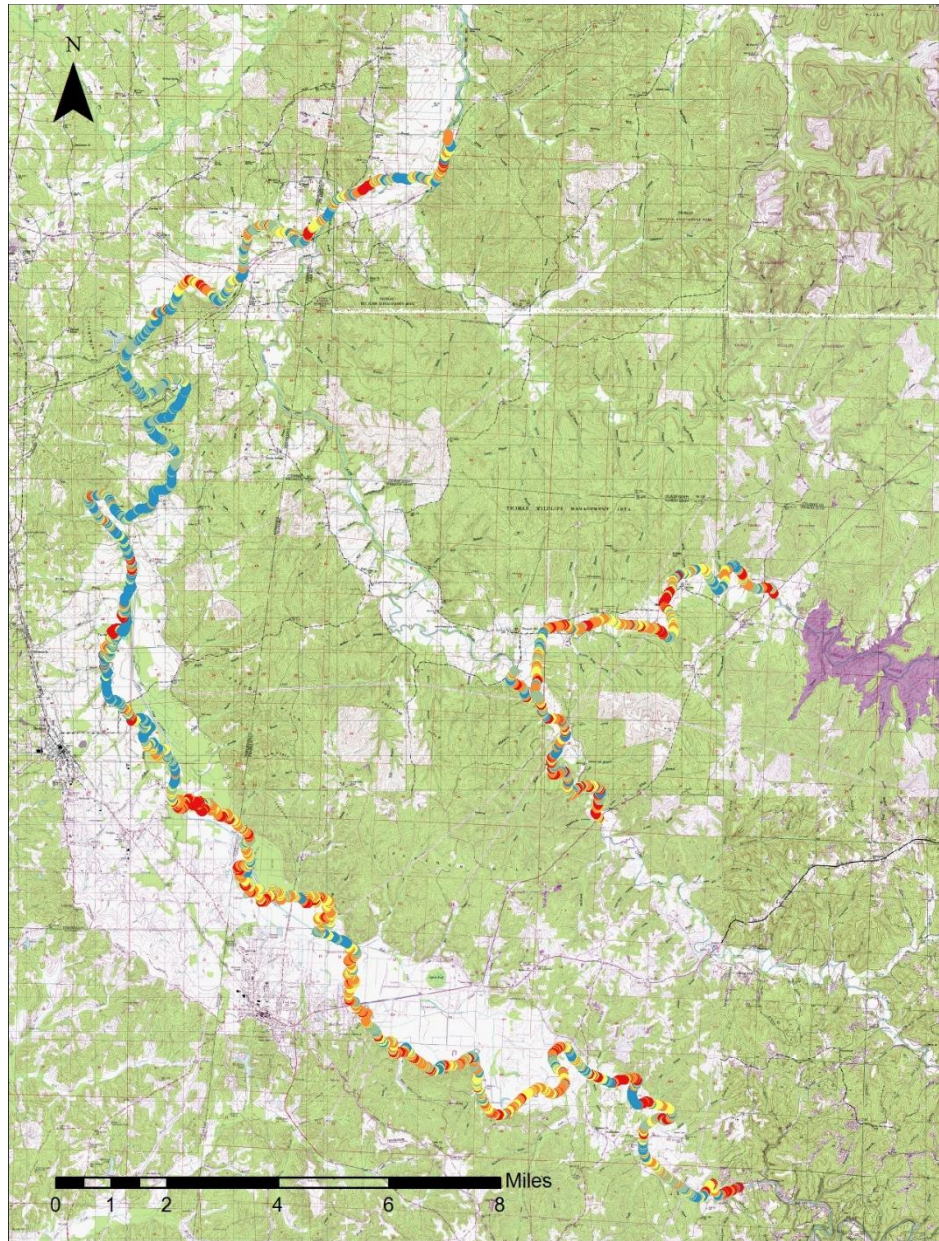
Map 1: The 56,000 data points for Left BES1 scores over the entire project area.

Maps of the entire project area BESI scores are produced for both left (Map 1) and right (Map 2). At this scale, the obvious trend is the long stretch of low BESI scores around Tishomingo State Park likely reflecting the abundant Cypress trees that line the streambank preventing erosion. It is easy to locate the high BESI scores surrounding the confluence of Little Bear and Cedar Creek but is hard to make any judgments on the cause at this scale.

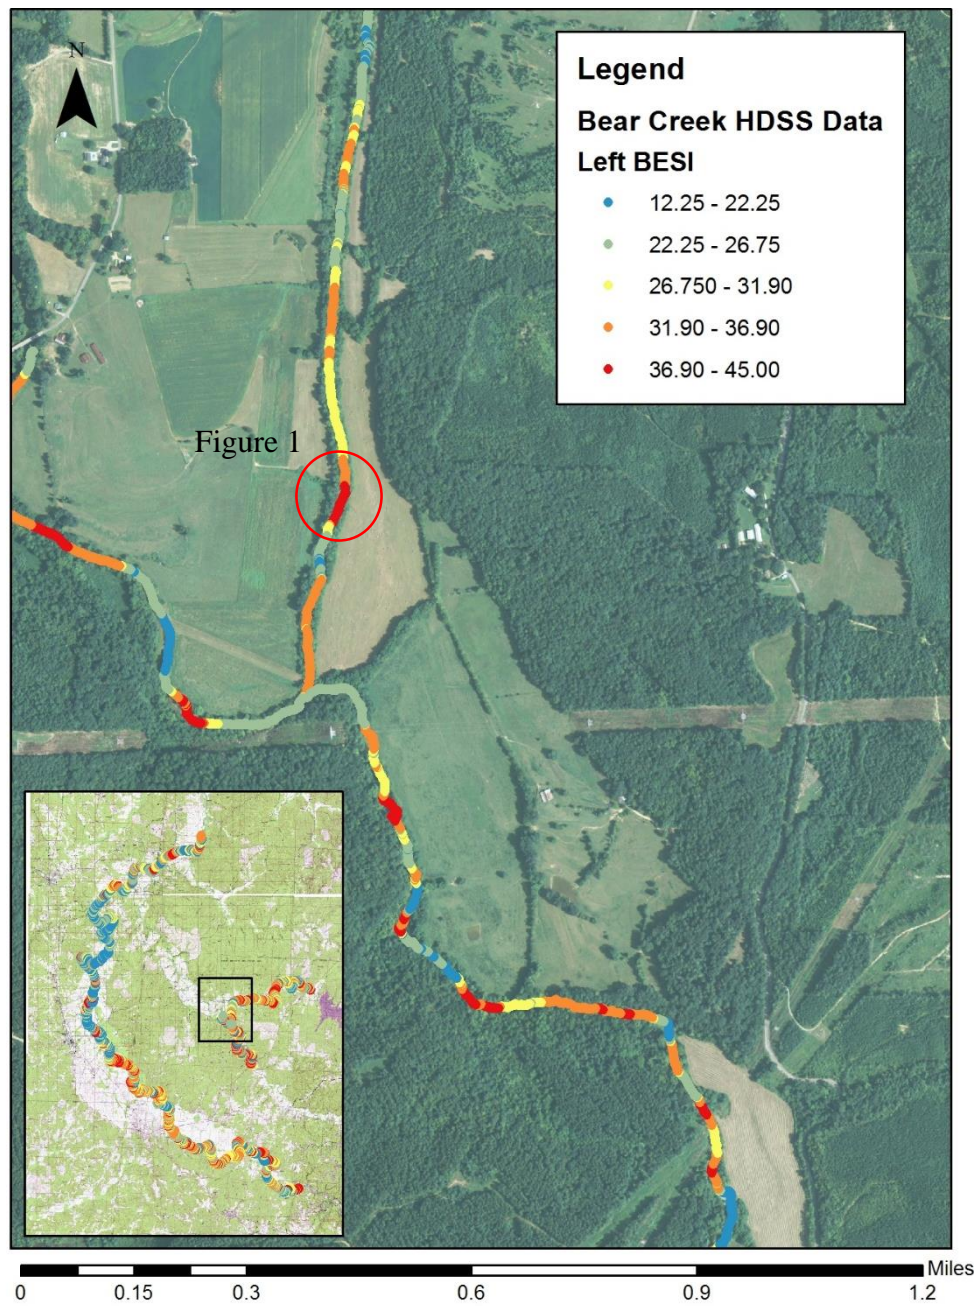
Map 3: Close up of Left BESl at confluence of Little Bear and Cedar Creek.

Looking closer with Map 3 and Map 4 at the confluence area of Little Bear and Cedar Creek, the lack of riparian cover and agriculturally dominated land use become the obvious reasons for high BESI scores. Figure 1 and Figure 2 are geo-referenced on the map and show the actual conditions during the survey.

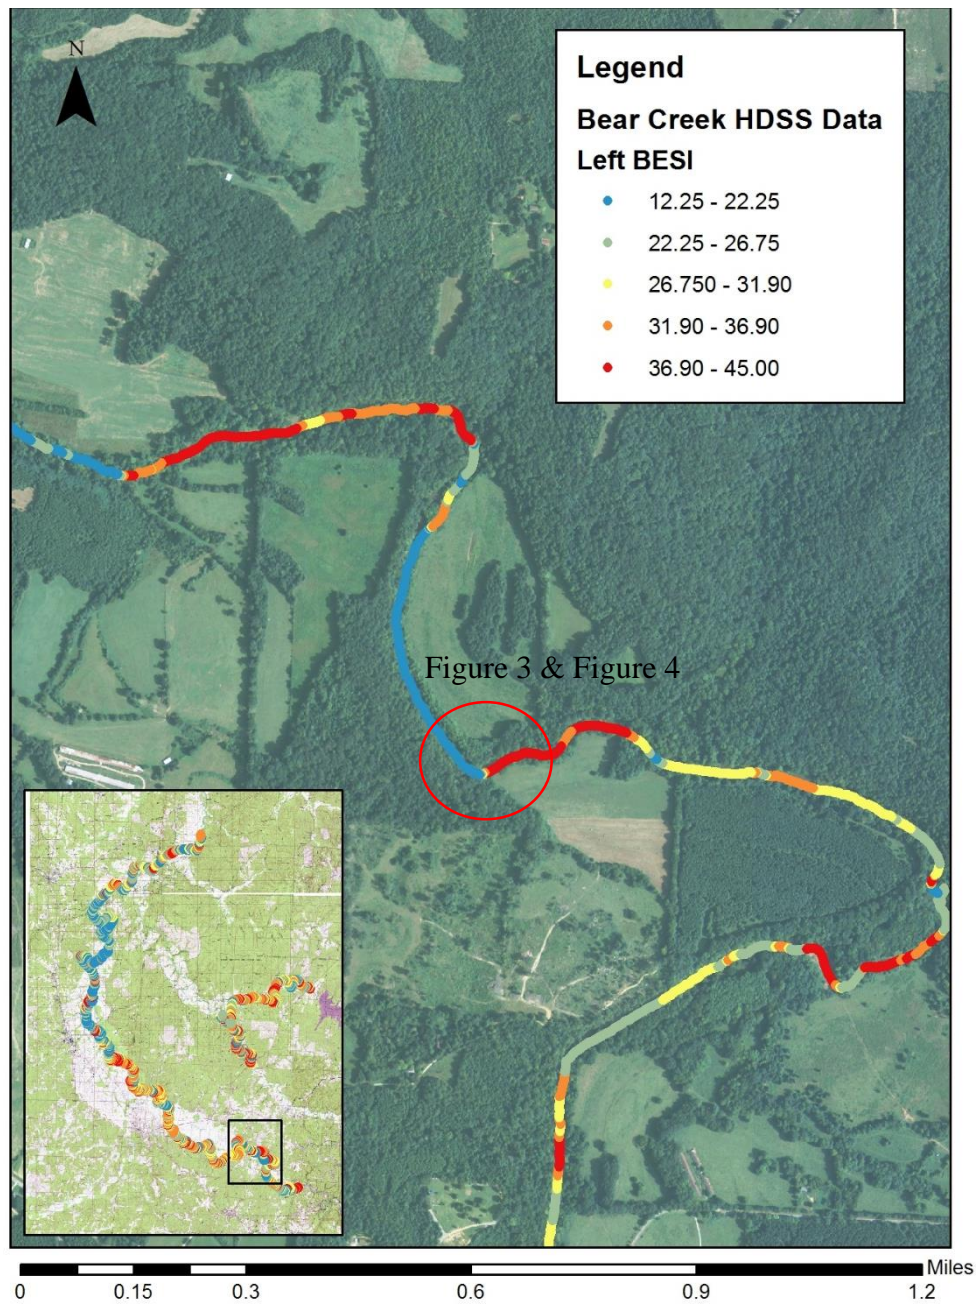
Map 5: Close up of Left BESl scores on Bear Creek

Map 5 not only highlights some very high BESI scores, but also very low scores which shows how dynamic a river can be. Map 6 shows the right side of Bear Creek which has the same pattern and is displayed in Figure 5 and Figure 6. These results highlight some of the powerful

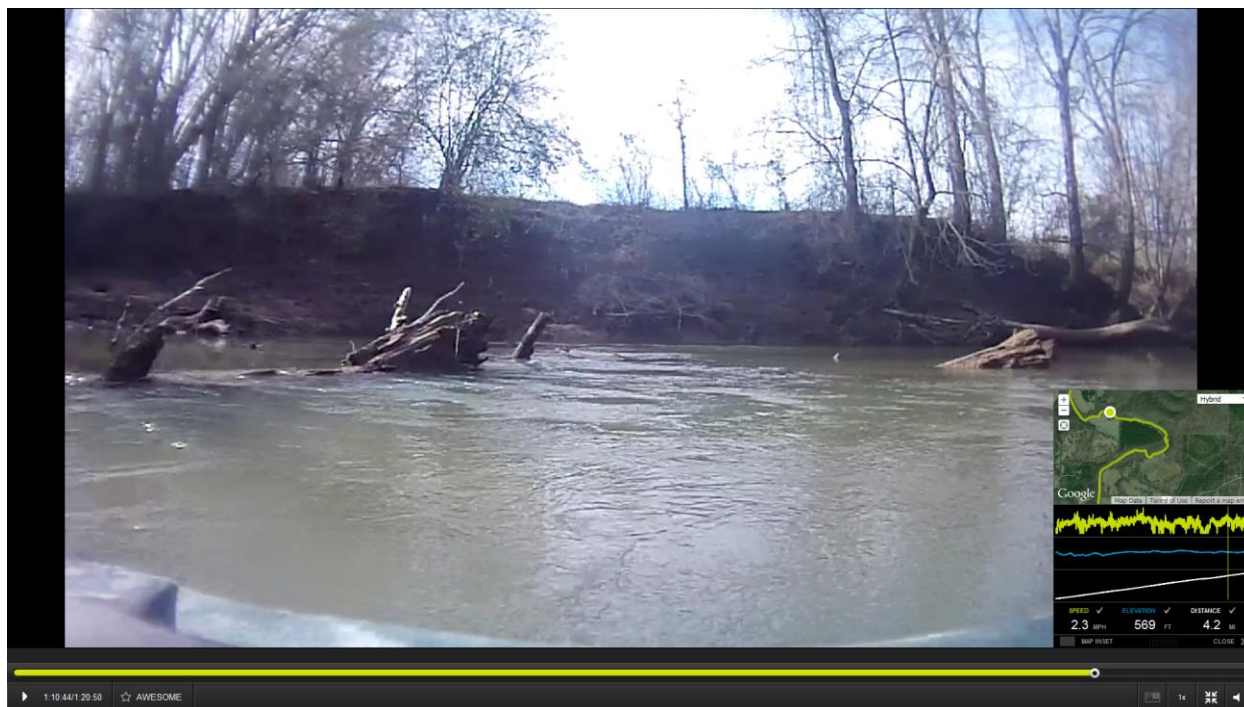
Figure 3: Video File; Bear Creek Left 11, 1:10:44

differences between the HDSS approach to traditional surveys. Traditional point or couple hundred meter samples typically are assumed to be representative of miles of stream. If a traditional survey was performed at the locations of Figure 3 or Figure 4, extrapolating the data would be very inaccurate. Using the HDSS approach, we continuously samples every second and eliminates the need for extrapolation.

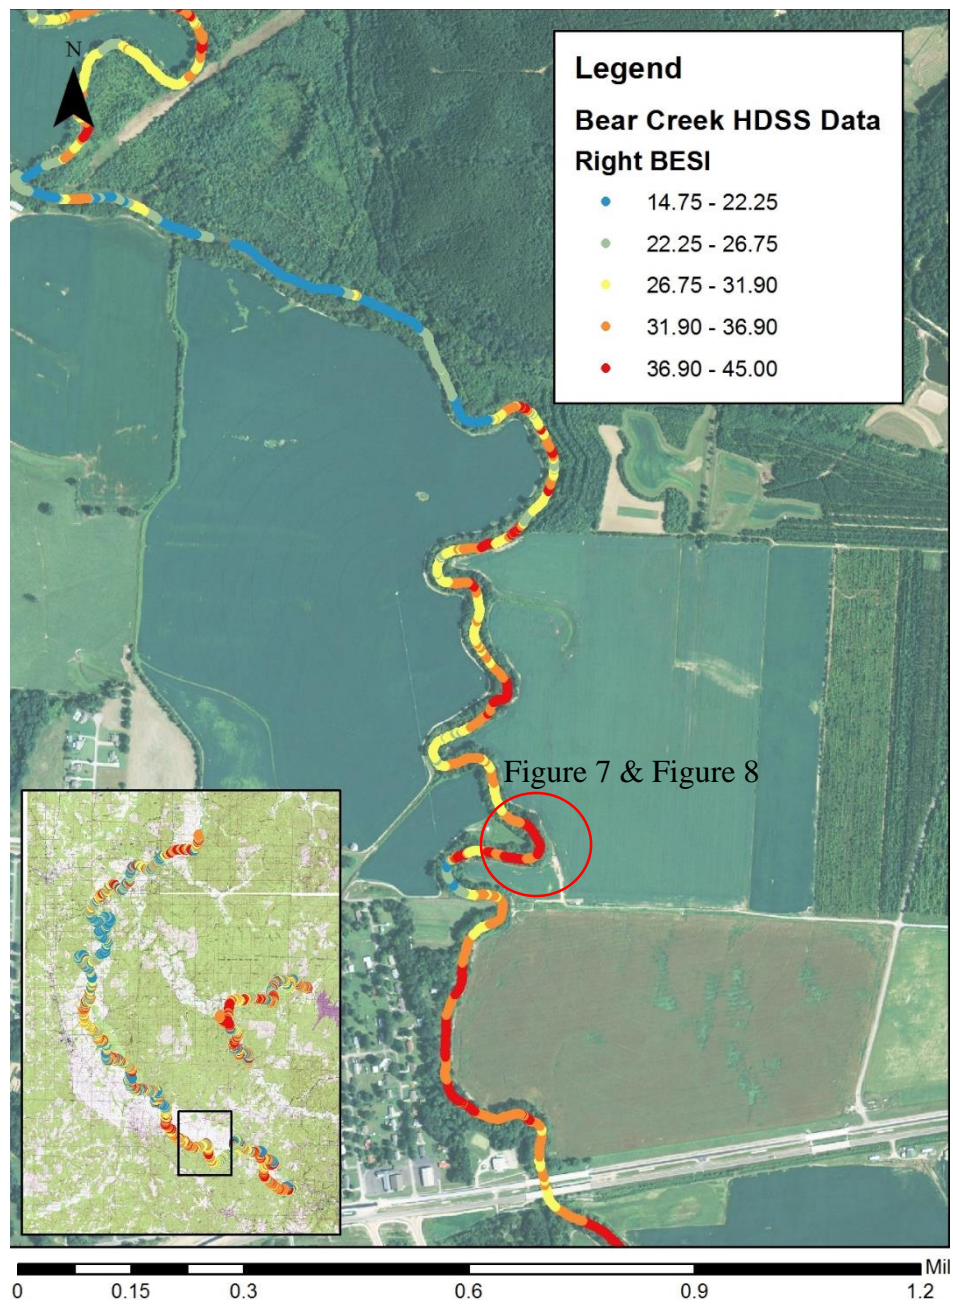
Map 7: Close up of Right BESl scores on Bear Creek

Map 7 is an area with high BESI scores for multiple possible reasons. Land use practices causing lack of riparian diversity would be a likely issue and possibly complicated by higher peak flows from the impervious surfaces just upstream in Red Bay. Figure 7 shows an actively slumping streambank with Figure 8 showing a farmers attempt to prevent more erosion. The benefit of a large riparian buffer is obvious once Bear Creek flows back into a forested section.

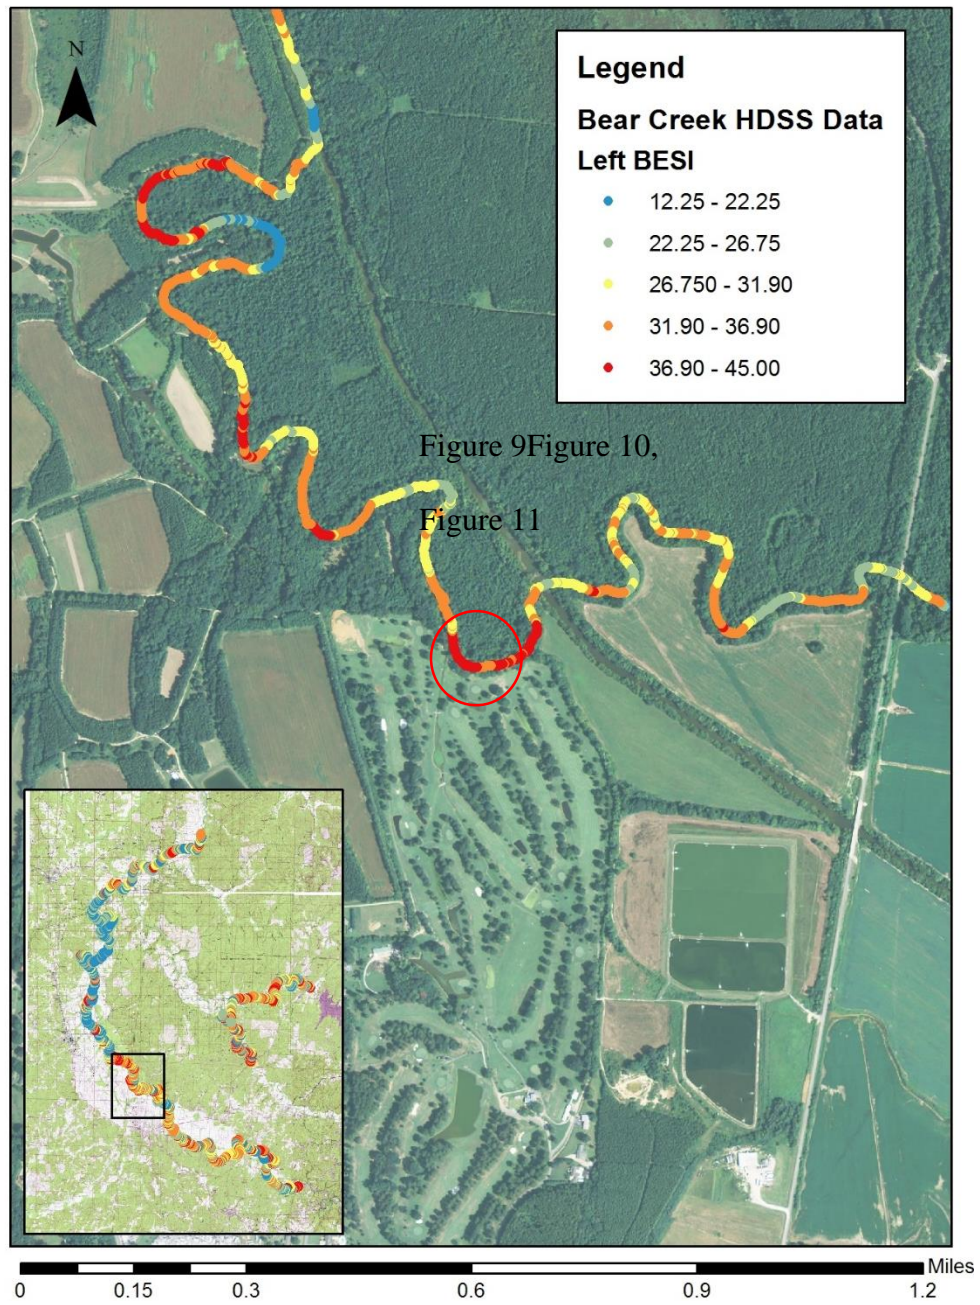
Map 8: Close up of Left BESl scores on Bear Creek

Map 8 highlights how outside bends often show higher BESI scores likely reflecting higher levels of sediment input from actively eroding streambanks. The red circle encompasses the next 3 pictures which are the worst areas surveyed in this whole project. Figure 9 shows the bottom of large tree roots and actively slumping streambanks. In addition to high BESI scores from the golf course, a pipe that is discharging bubbling green effluent was also located here (Figure 10). Another issue for this area is the highly incised tributary flowing through the golf course has a high probability of contributing excess nutrients to the stream (Figure 11).

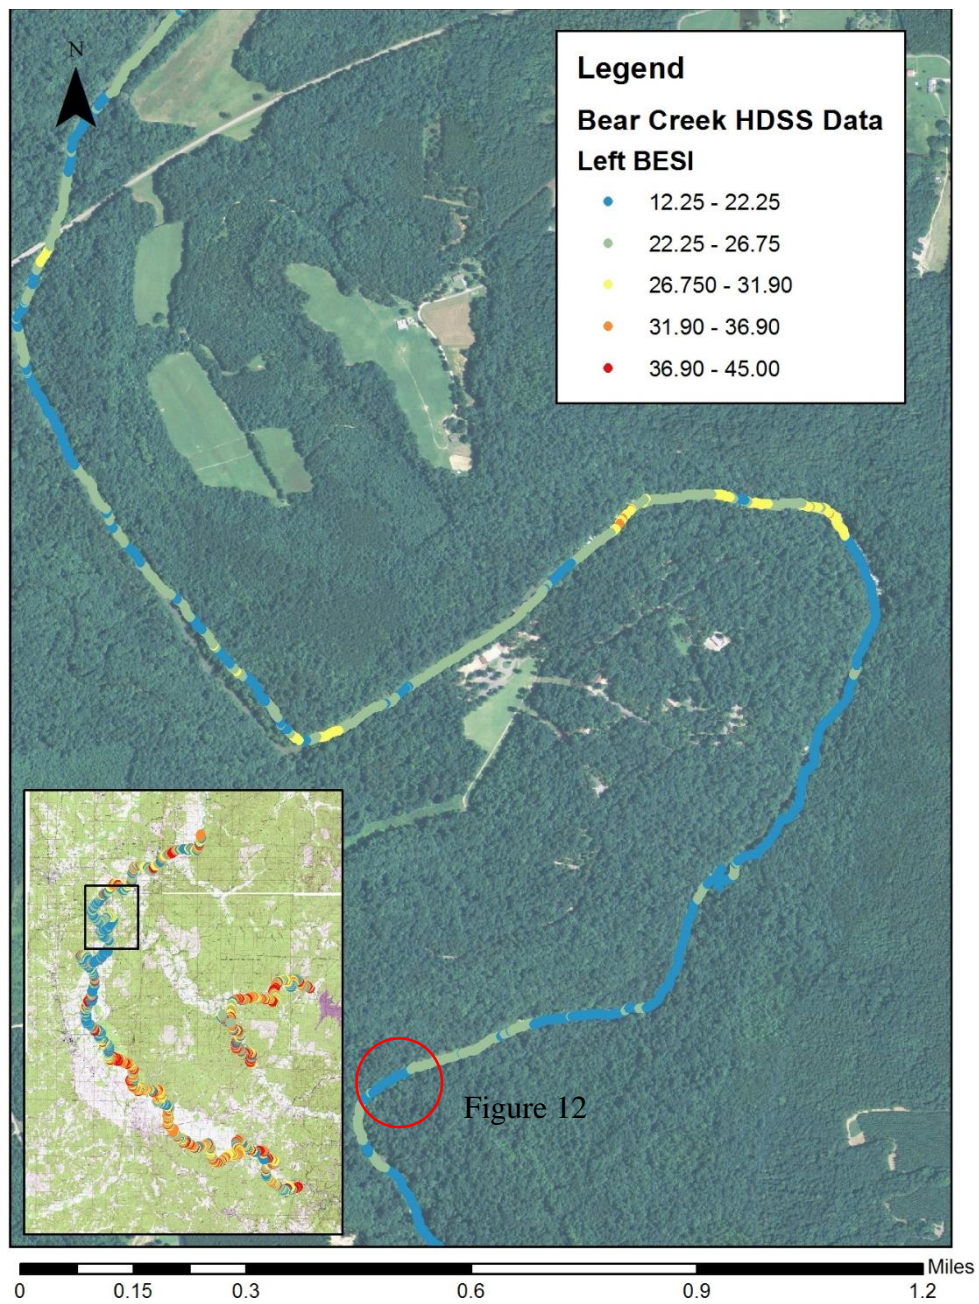
Map 9: Close up of Left BESl scores on Bear Creek

Map 9 and Map 10 highlight the lower BESI scores that can be seen for long stretches in Tishomingo State Park. Lack of agriculture and a presence of large Cypress trees in the riparian zones contributed highly to the low erosion potential scores. The presence or absence of Cypress trees highly influenced each parameter of the Bank Erosion Susceptibility Index (Figure 12 and Figure 13).
