High Definition Stream Surveys of Turkey Creek, AL

July 15, 2016

**Trutta Consulting
and
Parham & Associates Environmental Consulting**

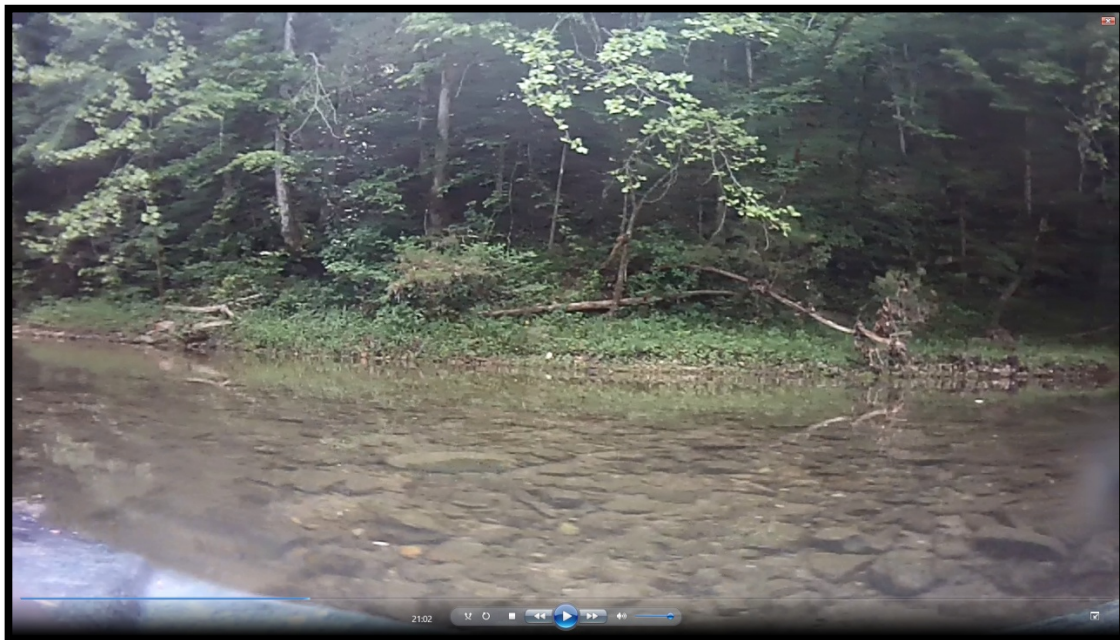
Figure 5: Level 1, Optimal Condition: Banks currently in optimal condition with excellent surface protection and low erosion potential. Includes stabilized areas such as bedrock outcroppings, heavily wooded areas, banks with low slopes and with good access to flood plain. No action necessary.

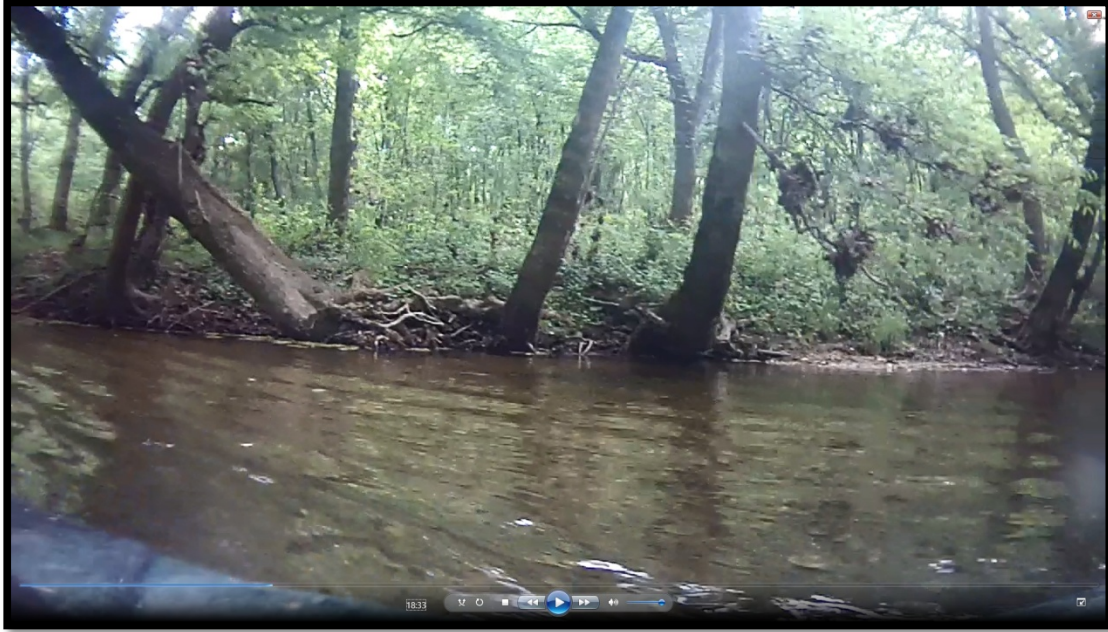
Figure 6: Level 2, Good Condition: Banks currently in good condition with minor impacts present. Includes heavily forested areas with moderate bank angles and adequate access to flood plains. No action necessary.

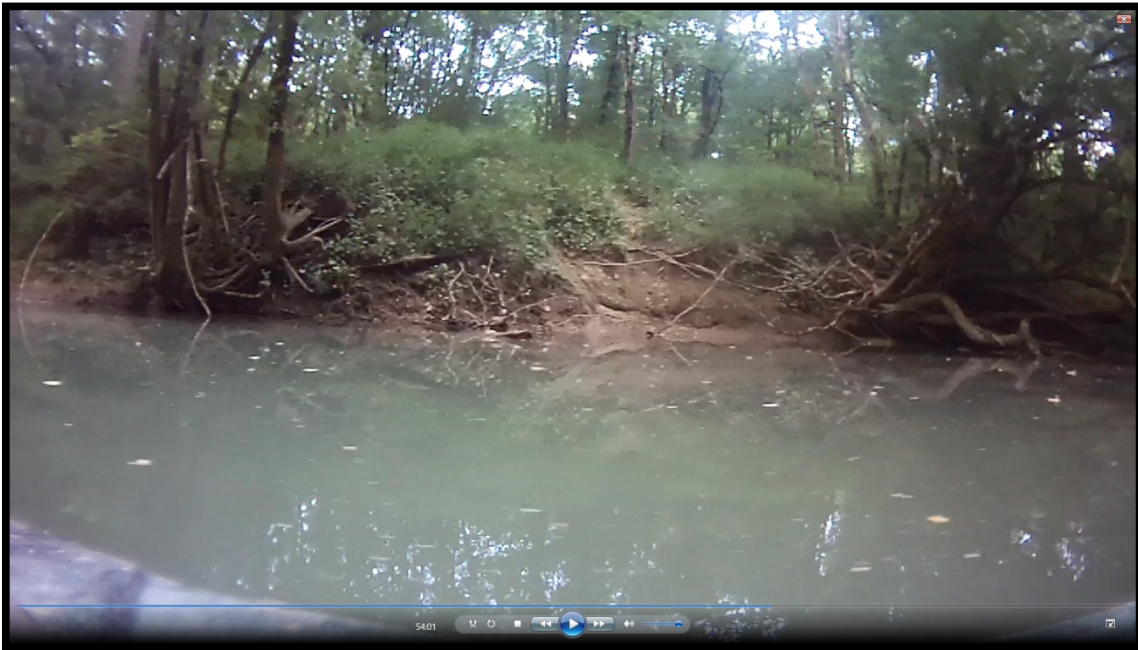
Figure 7: Level 3, Fair Condition: Banks showing moderate erosion impact with limited access to flood plain and variable surface protection. Potential impacts affecting water quality and aquatic habitat. Immediate action is not necessary.

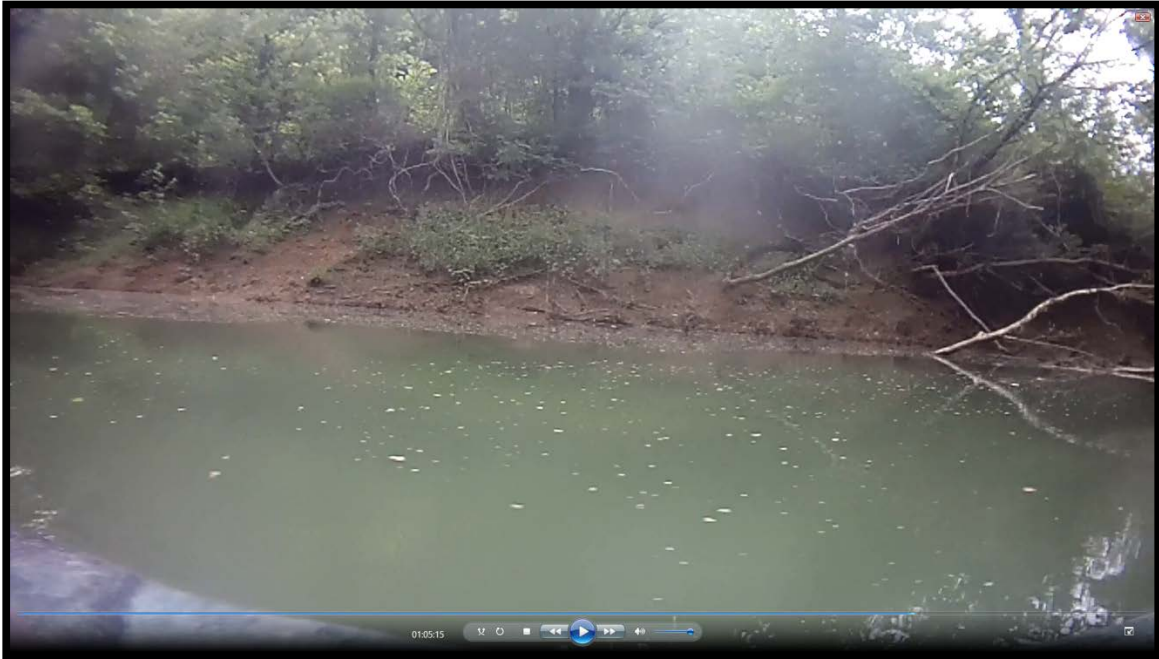
Figure 8: Level 4, Poor Condition: Banks with high erosion potential consisting of few trees and grass. Obvious impacts from cattle, agriculture, industry, with minimal connectivity to the flood plain. Source of negative impacts to water quality and aquatic habitat. Recommended action site.

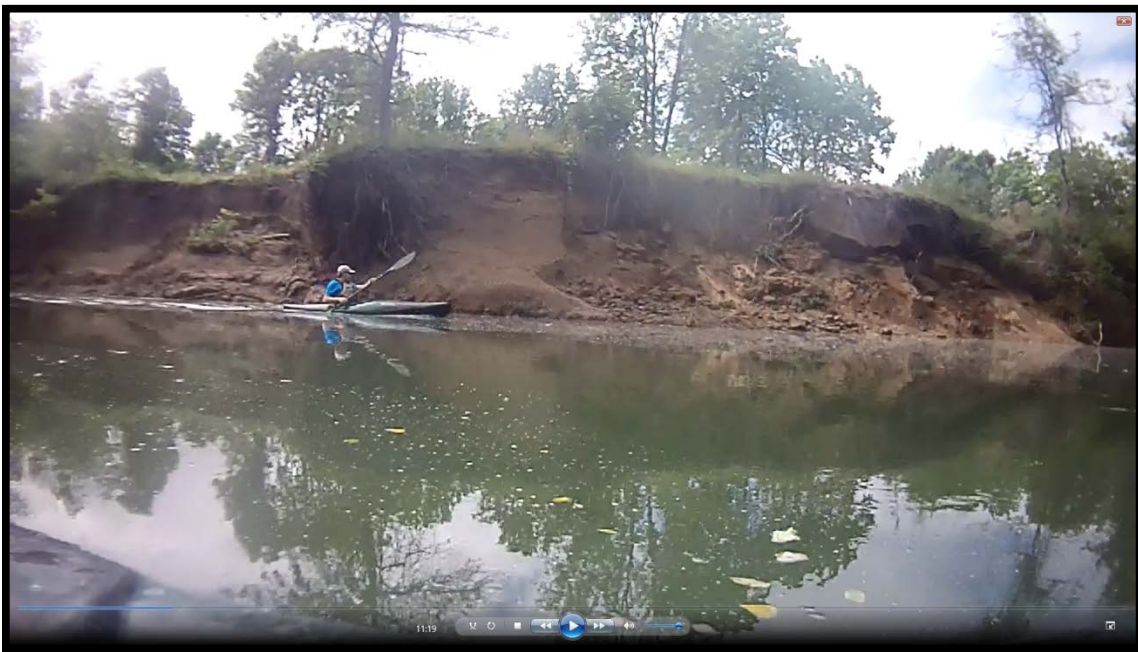
Figure 9: Level 5, Very Poor Condition: Banks with the highest erosion potential and steep bank angles. Evidence of active bank failure, with very little stabilization from vegetation. Obvious impacts from cattle, agriculture, and industry with no connectivity to flood plain. Contribution of sediment is very high in these areas. High source of negative impacts to water quality and aquatic habitat. Highly recommended action site.

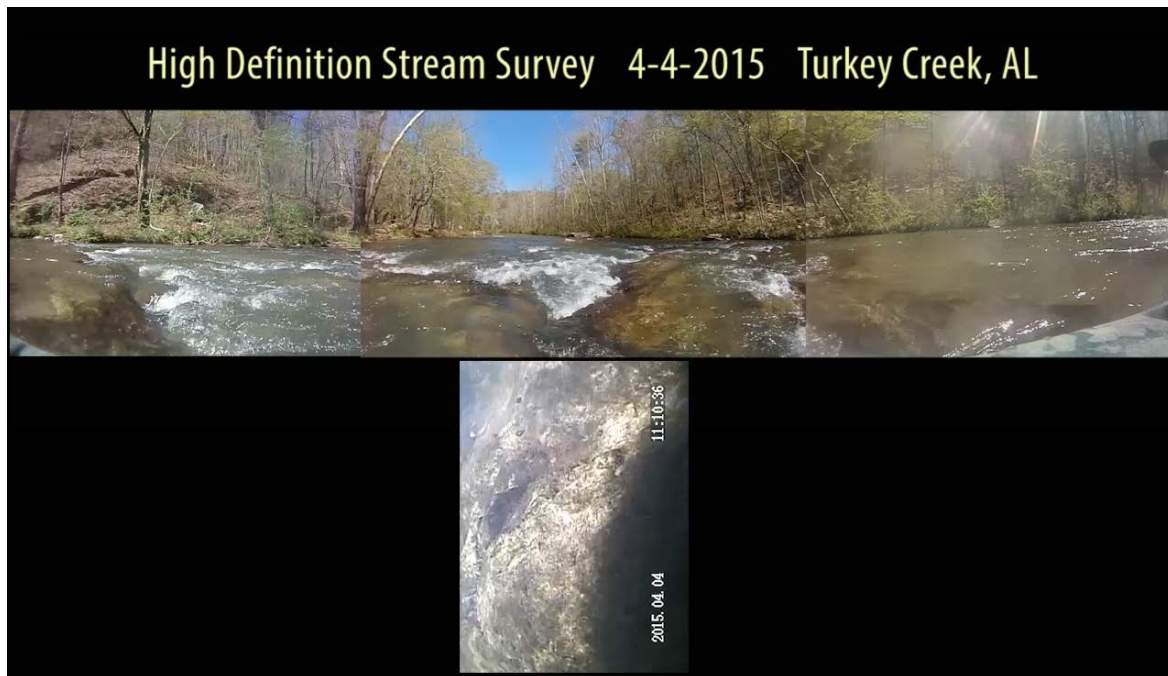
Figure 11: An example of the video from the kayak HDSS in a good section of Turkey Creek.

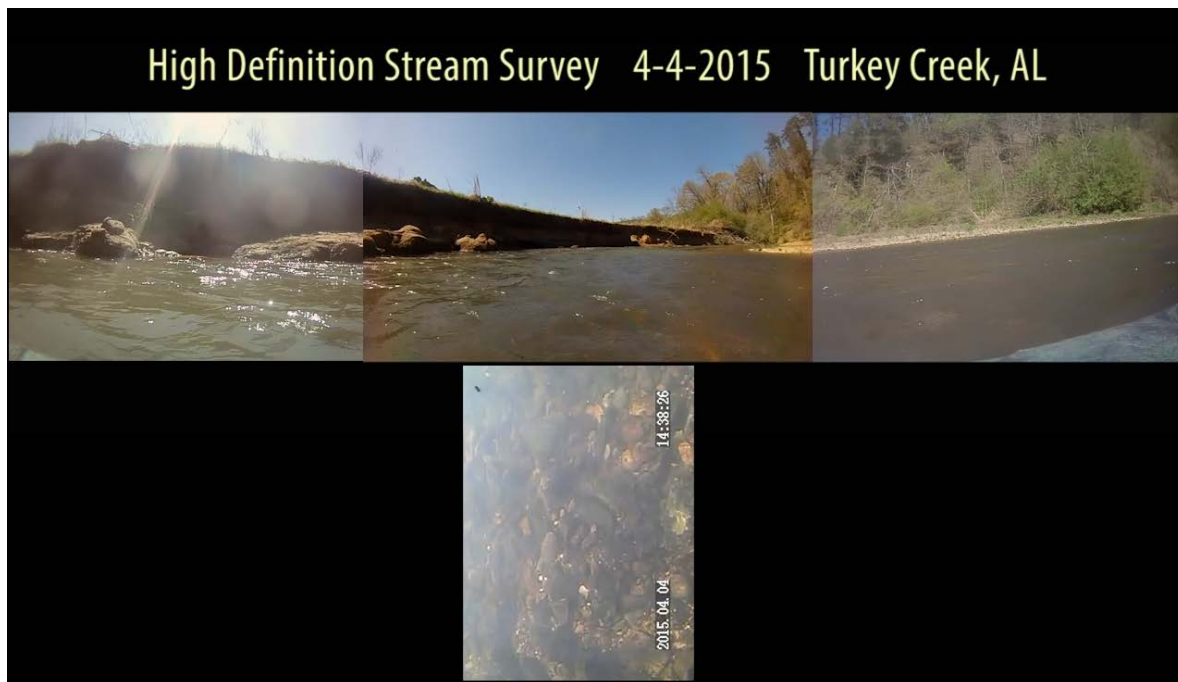
Figure 12: An example of the video from the kayak HDSS in a poor quality section of Turkey Creek. Note the bank failure on the left side of the image.

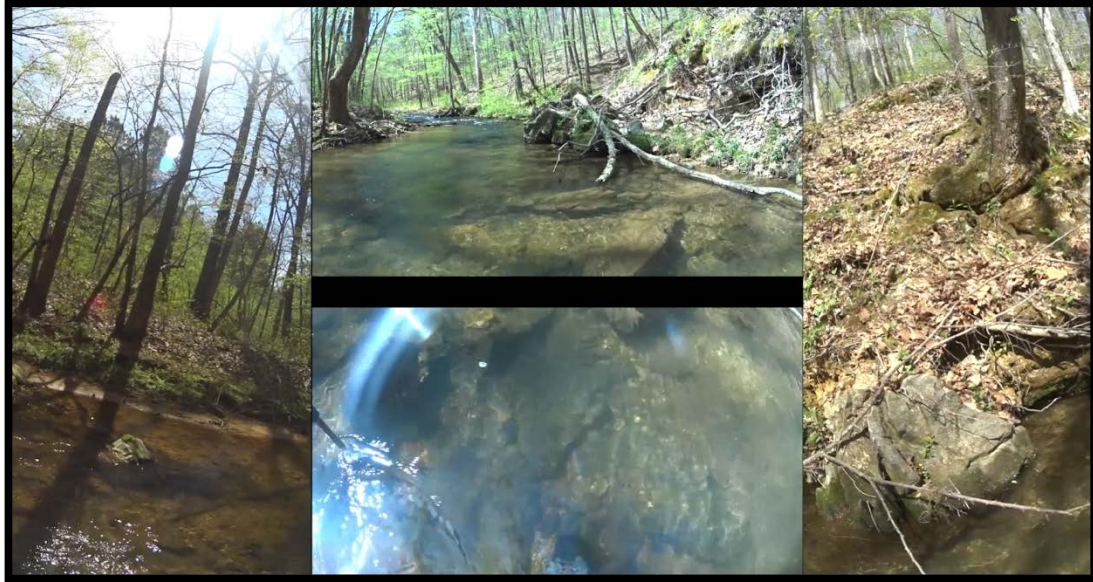
Figure 13: An example of the video from the backpack HDSS in a good section of Turkey Creek.

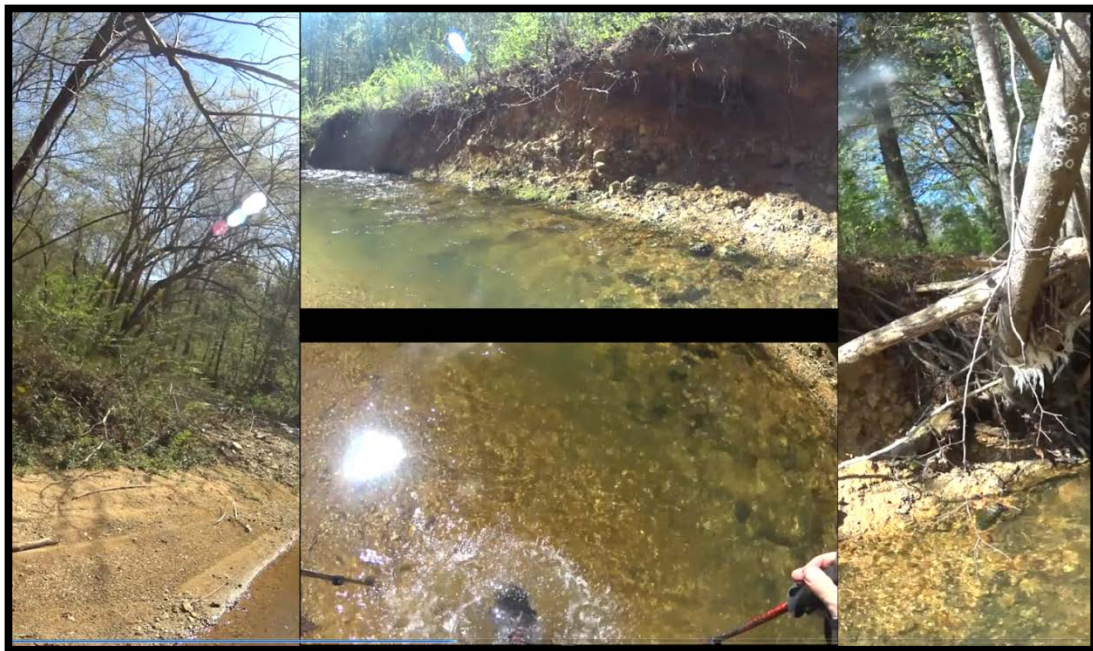
Figure 14: An example of the video from the backpack HDSS in a poor quality section of Turkey Creek. Note the bank failure on the right side of the image.

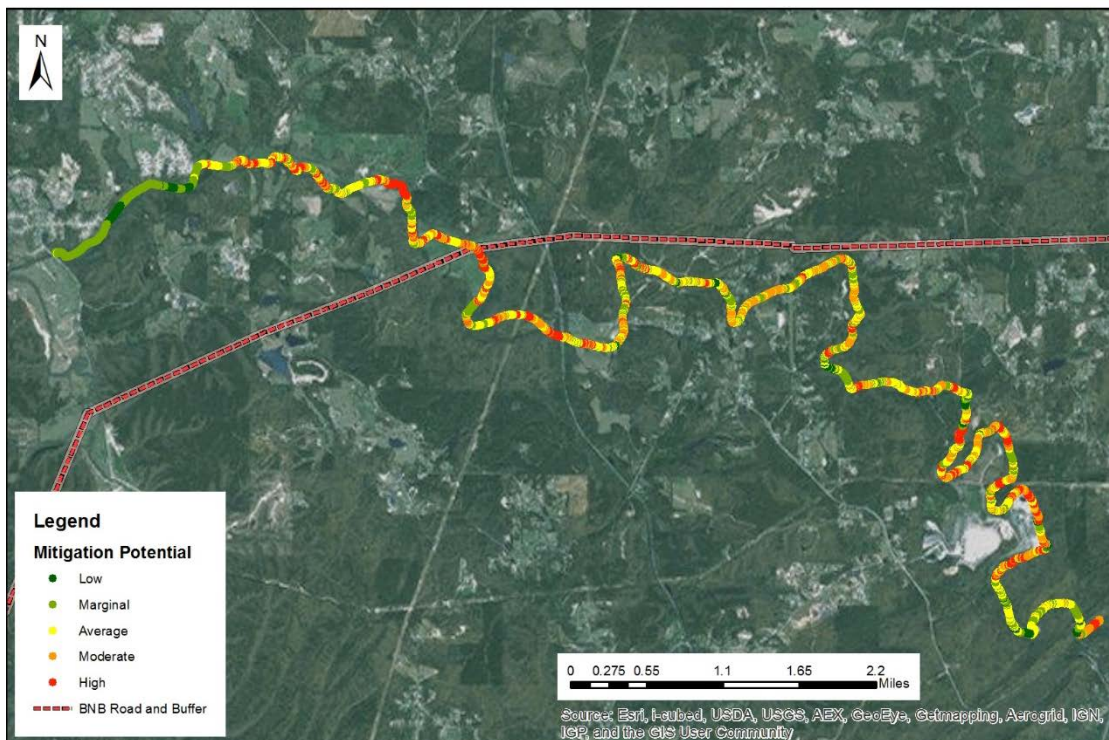
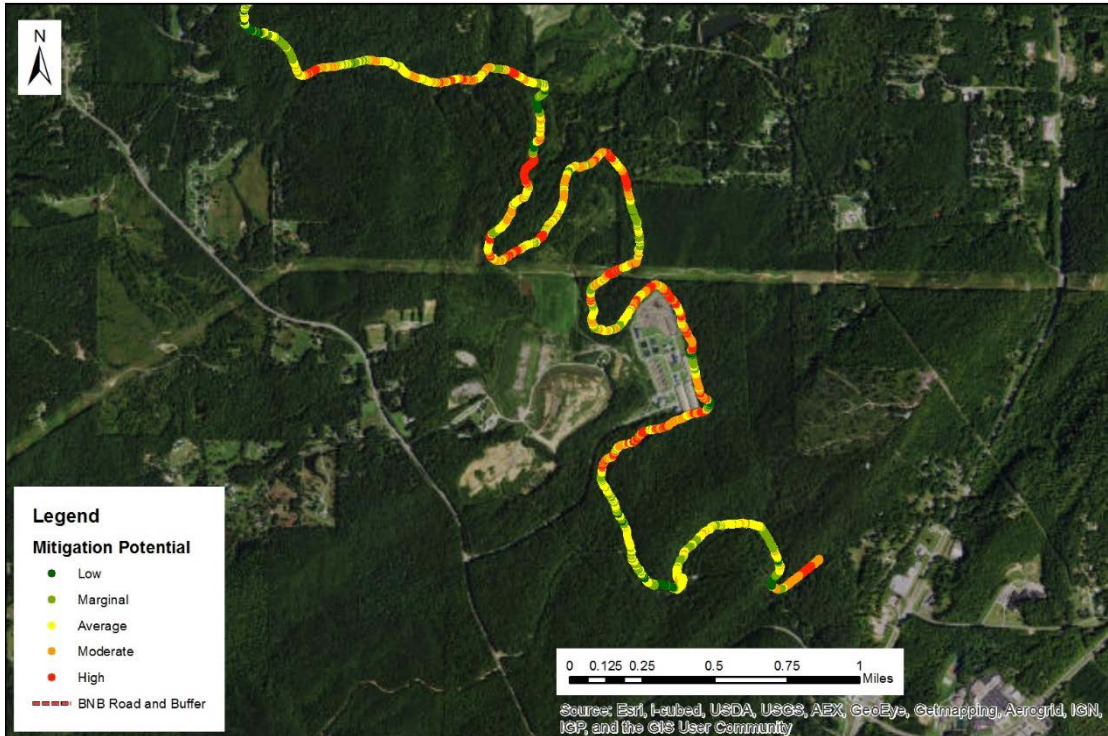
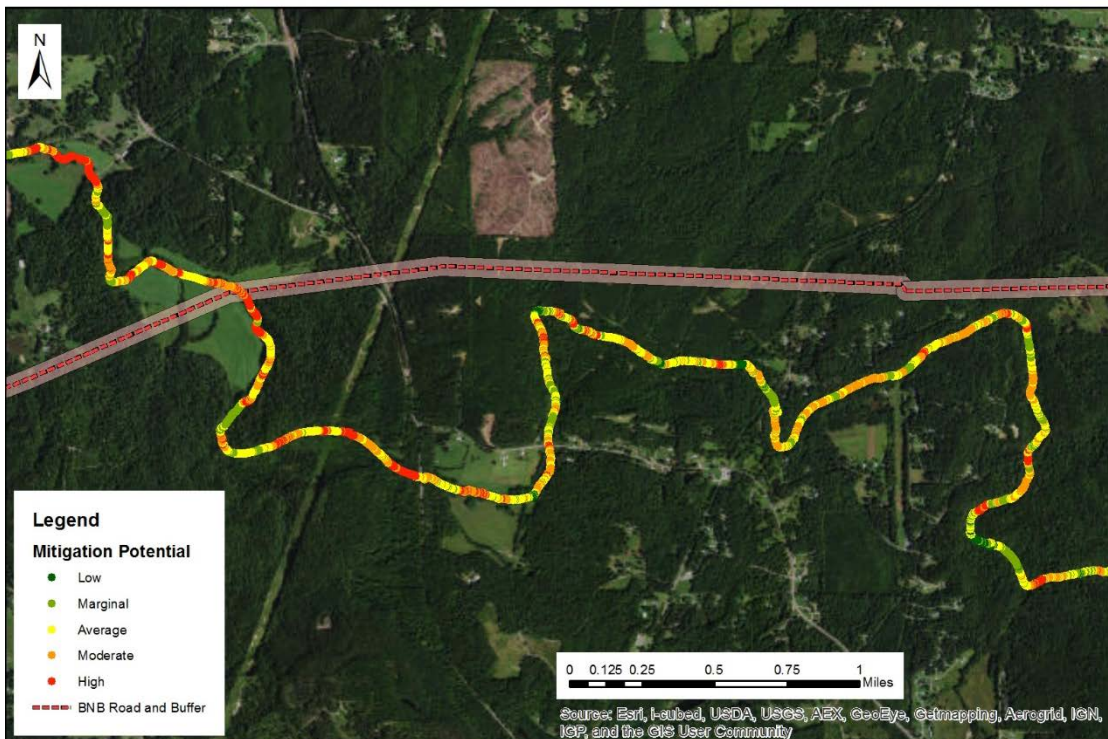
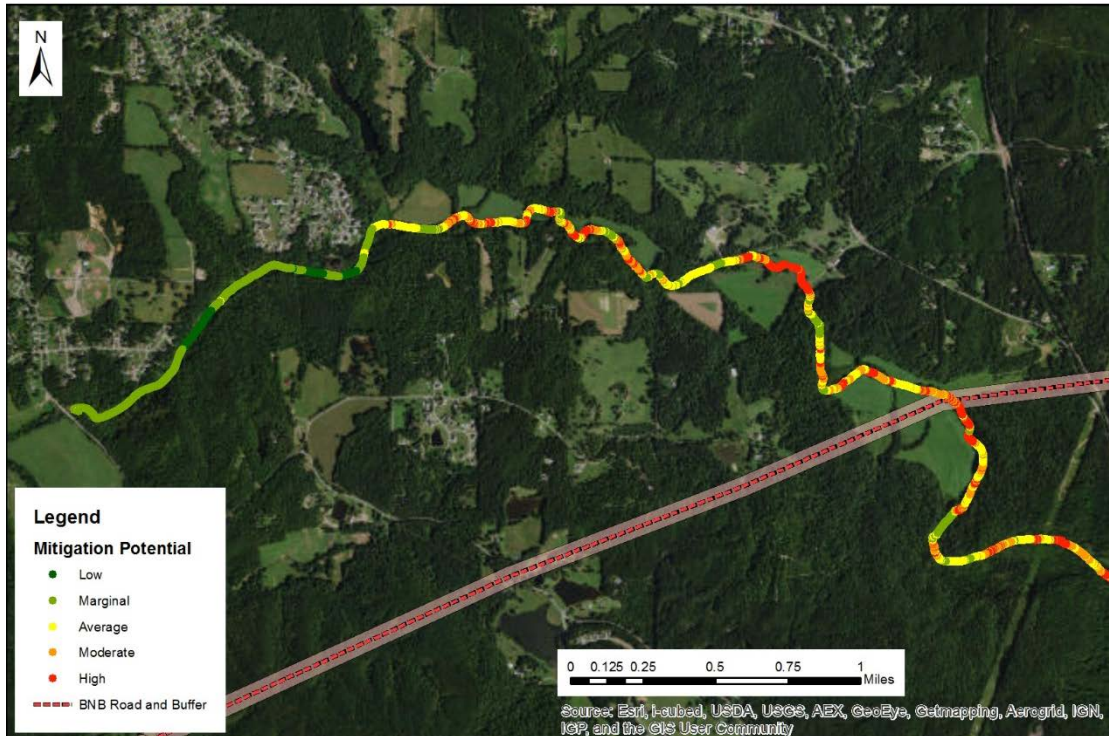
Map 18 - Map 21 show the whole project area as well as three additional maps for the upper, mid, and lower section associated with potential mitigation locations. The results show that restoration areas may be found throughout the stream segment and some are in close proximity to the BNB crossing location. Combining these results with land ownership, access, and other information would further aid in selecting the most cost effective mitigation locations.
