GEOLOGICAL SURVEY OF ALABAMA

**WATERSHED ASSESSMENT OF THE BIG CANOE CREEK SYSTEM
FOR RECOVERY AND RESTORATION OF IMPERILED AQUATIC SPECIES**

Bulletin 185

Tuscaloosa, Alabama
2016

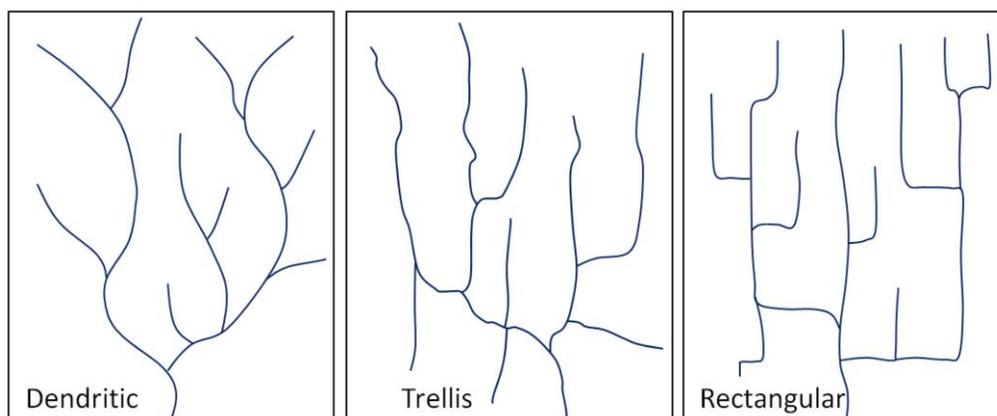
Figure 5.—Drainage patterns found in the Big Canoe Creek watershed (Earle, 2015).

Sandstones and shales of the Cumberland Plateau form impervious polygonal blocks with streams typically flowing along the well-developed joints. The resulting rectangular — drainage pattern (fig. 5) has straight line segments with right angle bends and tributaries also entering at right angles. Another distinctive drainage pattern found in Big Canoe Creek is the trellis pattern (fig. 5). Trellis drainage is characteristic of folded mountains; as a river flows along a strike valley, smaller tributaries feed into it from the steeper slopes on the sides of the valley. These tributaries enter the main river at approximately right angles, causing a trellis-like appearance (fig. 5) of the drainage system (Ritter, 2006). These two drainage patterns occur in many of the headwater streams of the watershed. The dendritic pattern is most prevalent in the more soluble rock found in the Birmingham-Big Canoe Valley District.

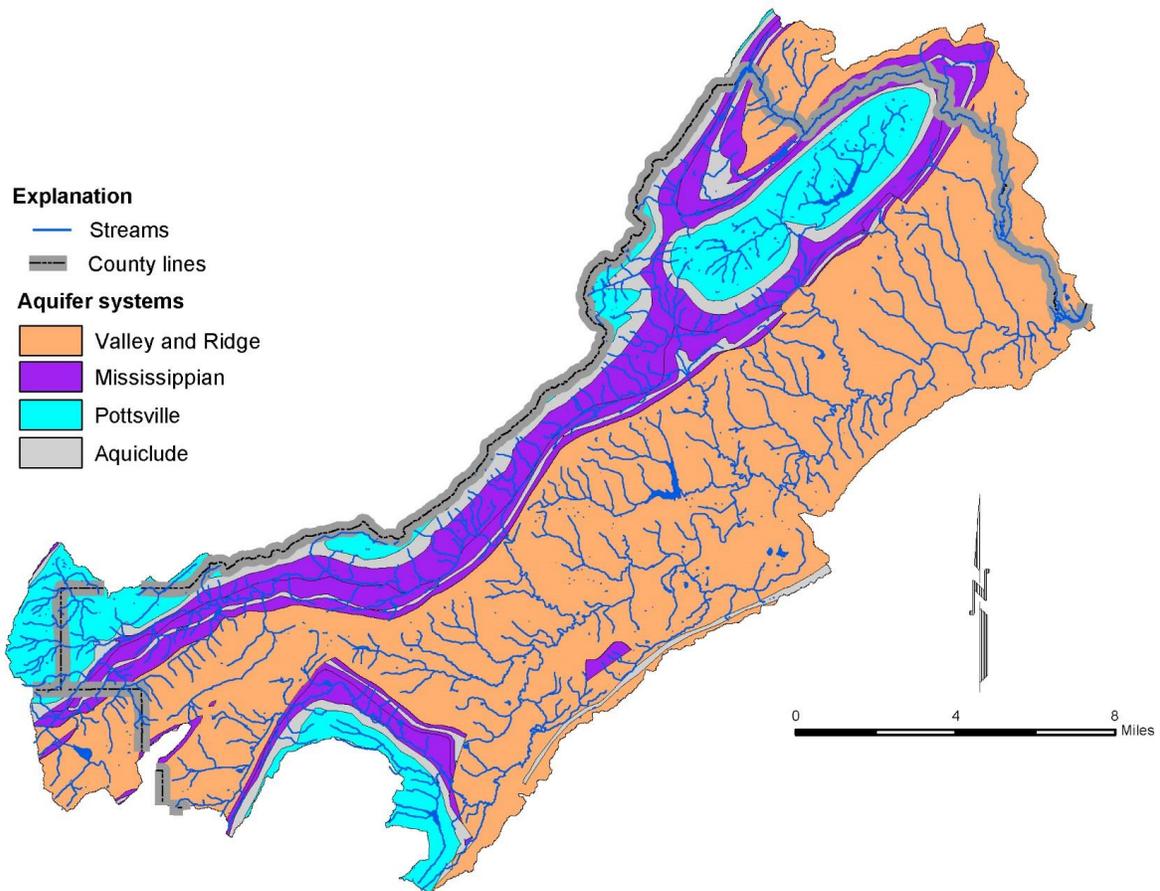
Figure 7.—Aquifer systems in the Big Canoe Creek watershed.

Groundwater is reliably found in the Valley and Ridge and Mississippian aquifer systems (fig. 7). The Pottsville aquifer is not a reliable source of large amounts of groundwater, but has been used as a source of water when no other aquifer is available. Areas underlain by the sandstone-based Pottsville aquifer contain softer groundwater than areas underlain by the predominantly carbonate formations of the Mississippian and Valley and Ridge aquifer systems (fig. 8).

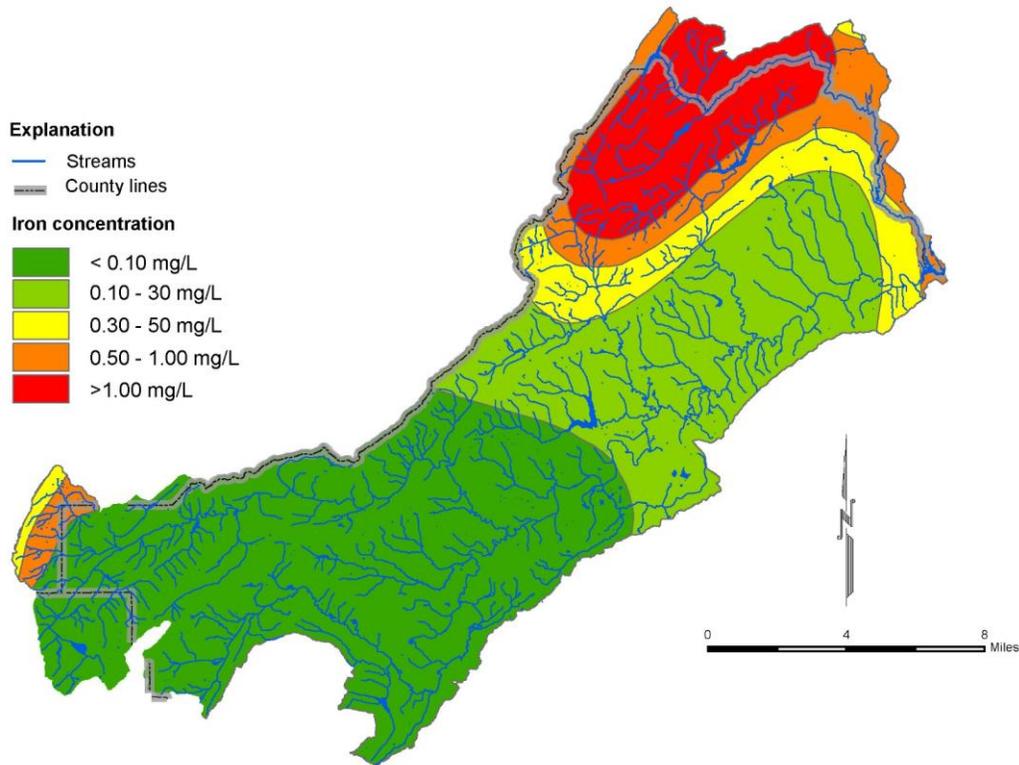
Figure 9.—Iron content of groundwater in the Big Canoe Creek watershed (Kopaska-Merkel and others, 2005).

Most wells in the Cumberland Plateau are completed in the Pottsville aquifer, where iron concentrations are variable but locally high (fig. 9), whereas groundwater in Mississippian aquifers in the Valley and Ridge physiographic section are relatively low in iron. Water with iron concentrations in excess of 0.3 milligrams per liter (mg/L) can stain plumbing fixtures, and the U.S. Environmental Protection Agency (USEPA) has defined 0.3 mg/L of dissolved iron as a secondary maximum contaminant level allowed in drinking water (USEPA, 2015b).

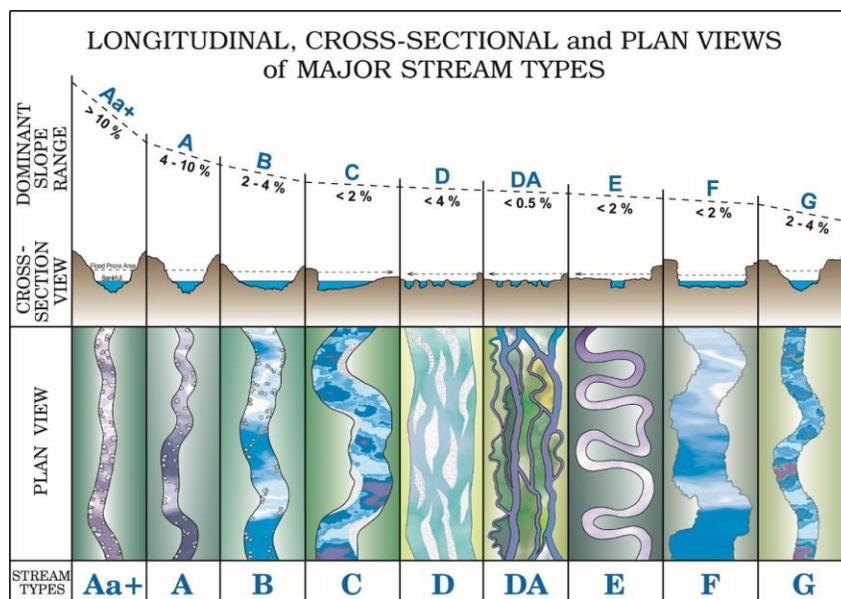
Figure 20.—The Rosgen Level 1 stream classification system (Rosgen, 1996).

The upstream (u/s) and downstream (d/s) channel morphology (metrics 1 and 2) are characterized using the Rosgen Level I stream classification (fig. 20) (Rosgen, 1996) to classify channels visually as either stable or not stable. Stream classes A, B, C, and E are considered indicative of stable channels (score 5) not severely impacted by road crossings. Waterways that are dammed by beavers, or a class DA, are scored 3 (moderately stable) and waterways that were ponded or class D, F, or G are scored 1 (unstable channels). Downstream channel/bank alteration (metric 3) scores 5 if little evidence of bank erosion or channel alteration is present, 3 if only minor or partial alterations are evident, and 1 if stream channels are highly modified. Altered channels can be highly incised and lack significant vegetative cover.

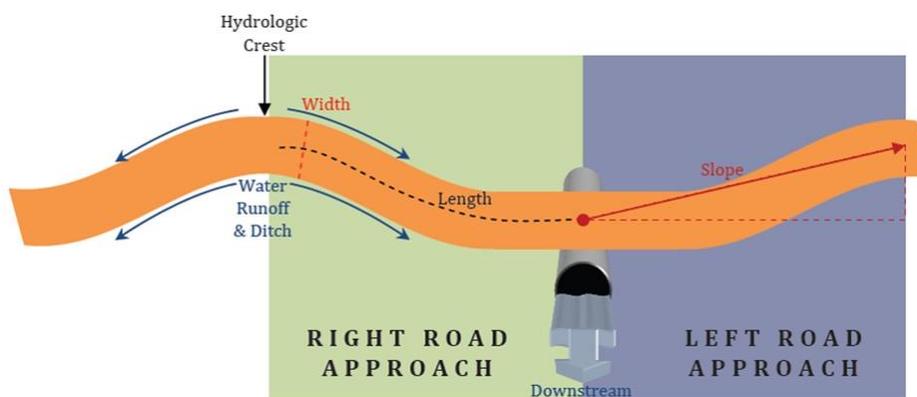
Figure 24.—Road approach dimensions (Witmer, 2009).

approach is [length of approach to topographic divide (miles) X road width (feet) X prism depth (inches) X 16.3] which equals cubic yards (c.y.) of sediment (fig. 24). This calculation is performed for both the right and left approach and then averaged. This metric scores 1 if the average volume is >40 c.y., scores 3 if the volume is 21 to 40 c.y., and scores 5 if volume is ≤ 20 c.y. It should be noted these criteria were derived for the Coastal Plain region of south Alabama and may need to be recalibrated for roads in other regions of the state.

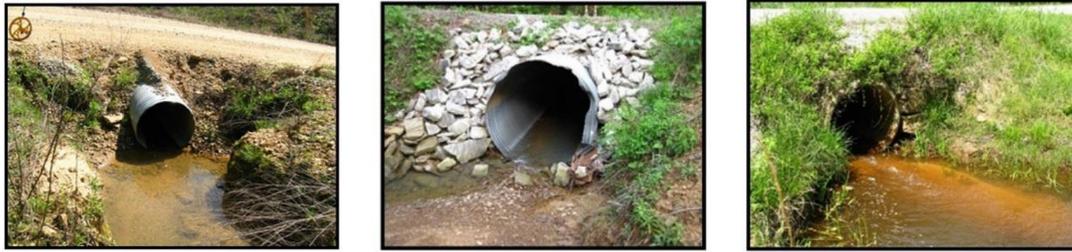
Figure 25.—Comparison of poor, fair, and good outlet conditions

The condition of the ditches paralleling road approaches and the outlets of these ditches to the stream are important sources and conduits of sediment to streams. Each outlet (metric 11) is scored either 1 (vegetated, riprap, or synthetic cover) or 0 (bare soil, concrete, or other poor covering material). The four outlets are added together and if the total equals 4, 2, or 0, then 1 is added to the total; if the total equals 1, then 2 is added; if the total is 3, then 0 is added. This procedure results in scores of 5 (good condition), 3, or 1 (poor condition). The procedure for ditches (metric 12) is identical to that for outlets and scores in the same manner. Figures 25 and 26 compare good and poor conditions observed during a survey.

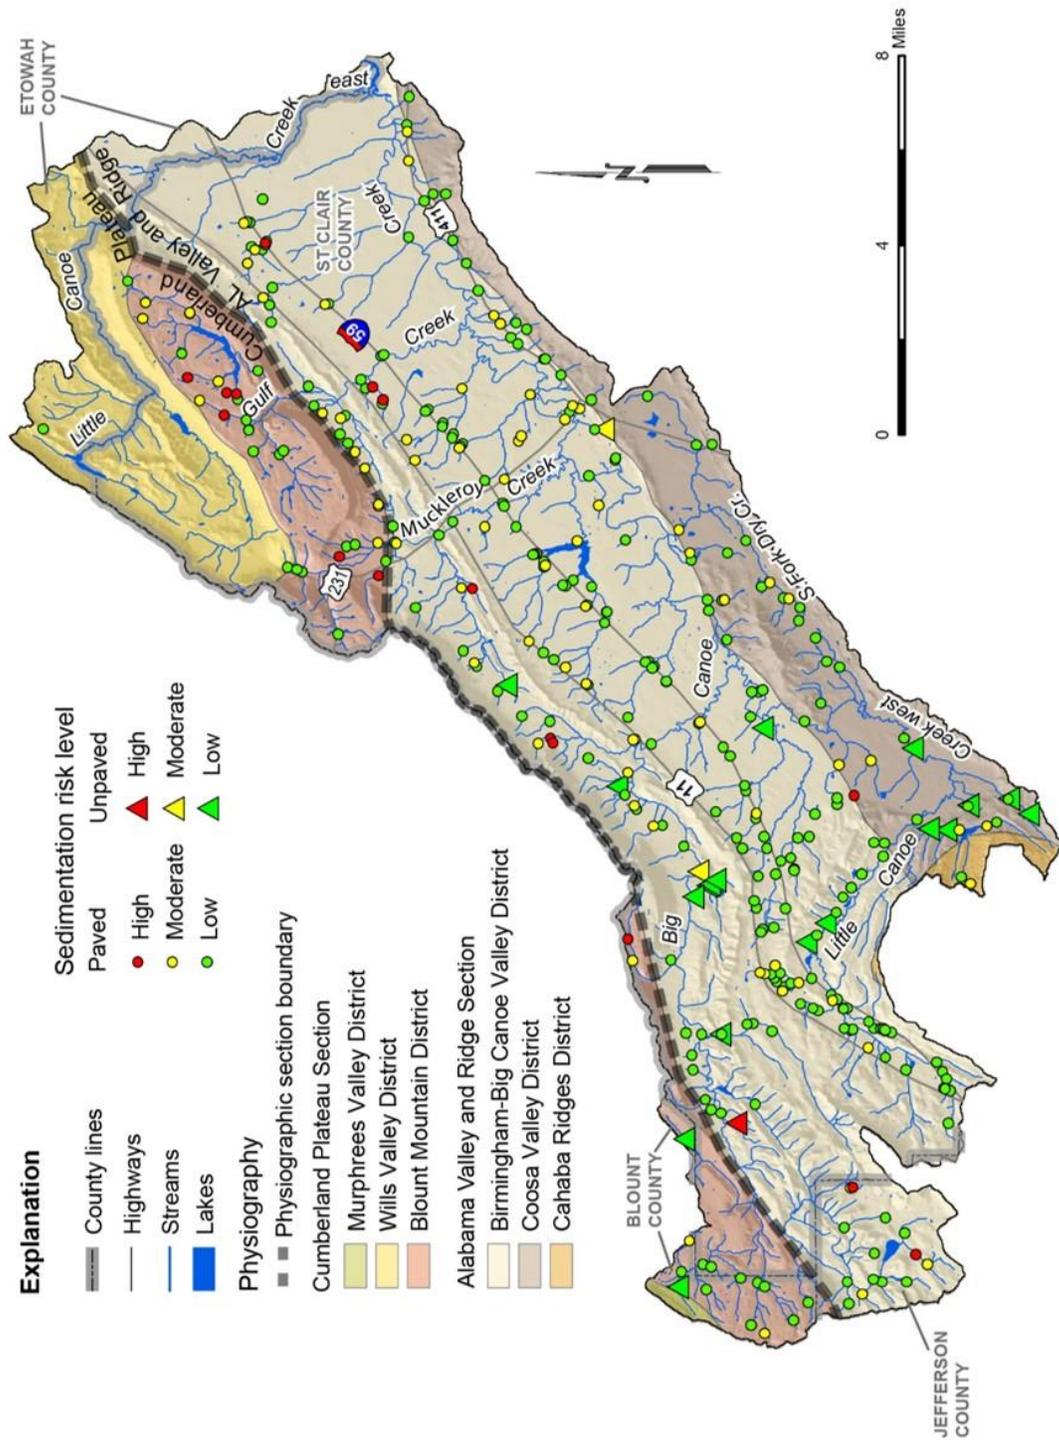
Figure 27.—Sedimentation risk level at sedimentation risk index (SRI) evaluation sites in the Big Canoe Creek watershed.

Few unpaved roads were encountered in the Big Canoe Creek watershed and only one rated high risk for sedimentation (appendix E). Unpaved roads generally present a higher risk of instream sedimentation effects compared to paved roads, but in Big Canoe Creek the unpaved roads were almost all at low risk for sedimentation. Sedimentation issues identified at high risk sites, both unpaved and paved roads, were related to the poor channel morphology (generally both upstream and downstream of the crossing), downstream channel and bank alteration/erosion due to the crossing structure, steep approaches to crossings, and poor to marginal crossing fill condition (appendix E). Crossing fill material that was not properly stabilized was a significant source of sediment at several sites.

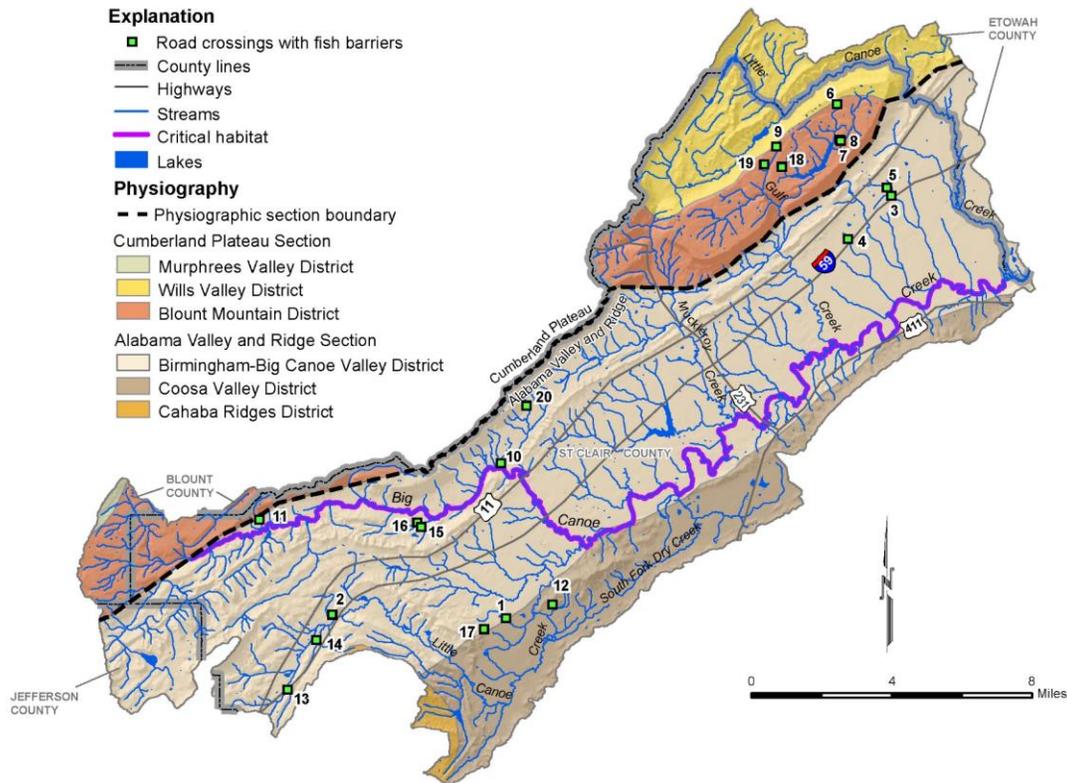
Figure 28.—Sites with fish barriers in the Big Canoe Creek watershed.

A major source of habitat impairment for aquatic fauna that was documented during the SRI surveys was lack of stream connectivity. Stream reaches become isolated by small dams and/or perched crossing structures, and these impediments restrict the movement of aquatic fauna during critical times. Connectivity of stream reaches and channels is necessary for species to access reproduction areas and allow for adequate gene flow among populations. This is often a problem for rare species because gene flow has become interrupted, ultimately leading to degraded genetic fitness and the decline of small, localized populations. Maintaining and restoring stream connectivity is an integral part of the SHU conservation mission.

precipitated by the crossing structure. The fish barriers and/or perched culverts identified in the SRI survey should be a restoration priority in the Little Canoe Creek (west) system, because the rare Trispot Darter occurs throughout the watershed. The habitat specificity of this species makes perched culverts a real threat that restricts access to critical breeding habitat.
