GEOLOGICAL SURVEY OF ALABAMA

EVALUATION OF SEDIMENTATION RISK AND HABITAT THREAT SEVERITY FOR STREAM CROSSINGS AND CRITICAL HABITAT IN THE NORTH RIVER STRATEGIC HABITAT UNIT, ALABAMA

VOLUME 1: REPORT

Open-File Report 1502

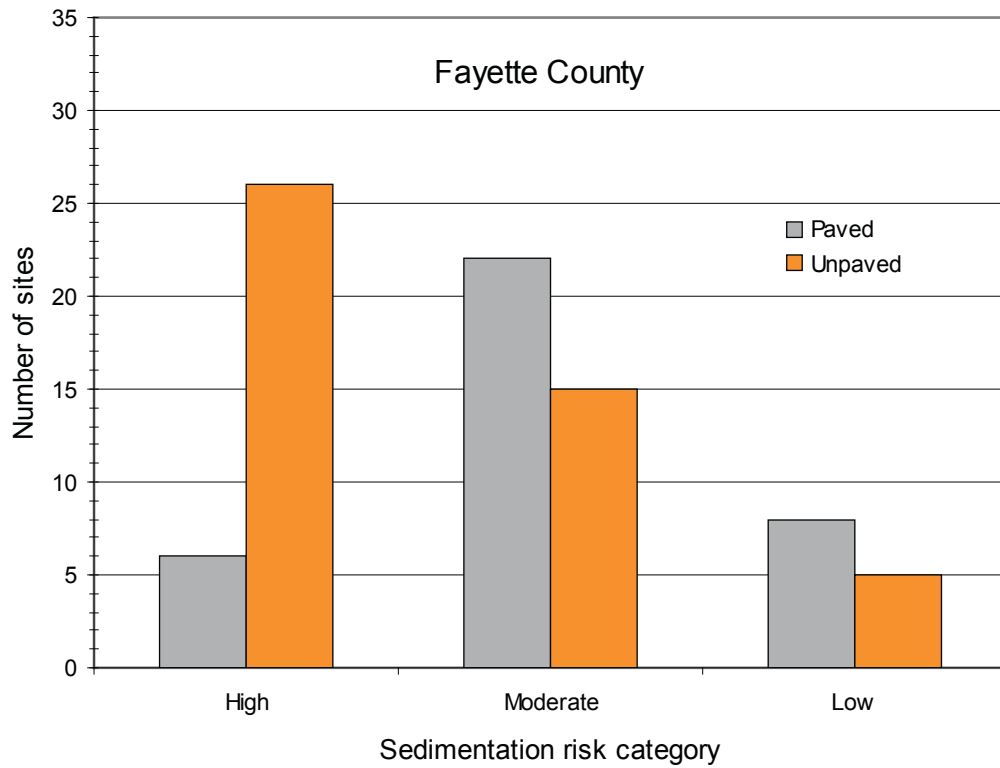
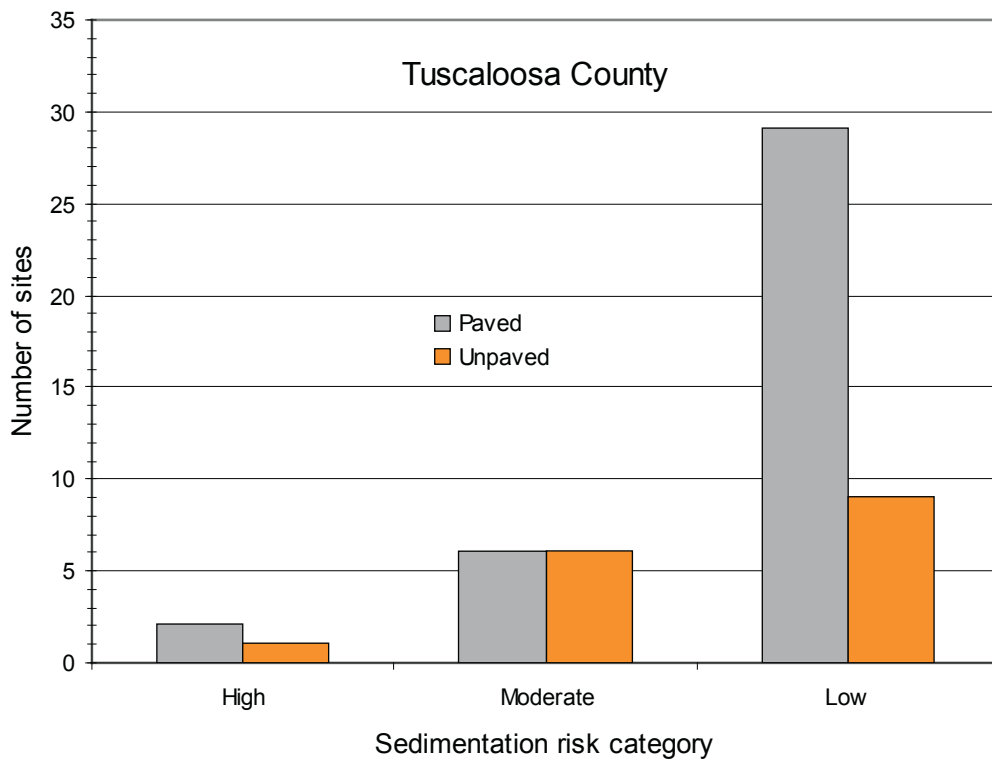
Figure 8. Distribution of road crossing type with respect to the sedimentation risk index for selected roads in Fayette and Tuscaloosa Counties.

Considering all 135 evaluations, 35 sites (25.9 percent) were at high risk for sedimentation, 49 sites (36.3 percent) at moderate risk, and 51 sites (37.8 percent) at low risk (appendix B, fig. 8). Fayette County had 32 sites at high risk while Tuscaloosa County only had three sites at high risk.

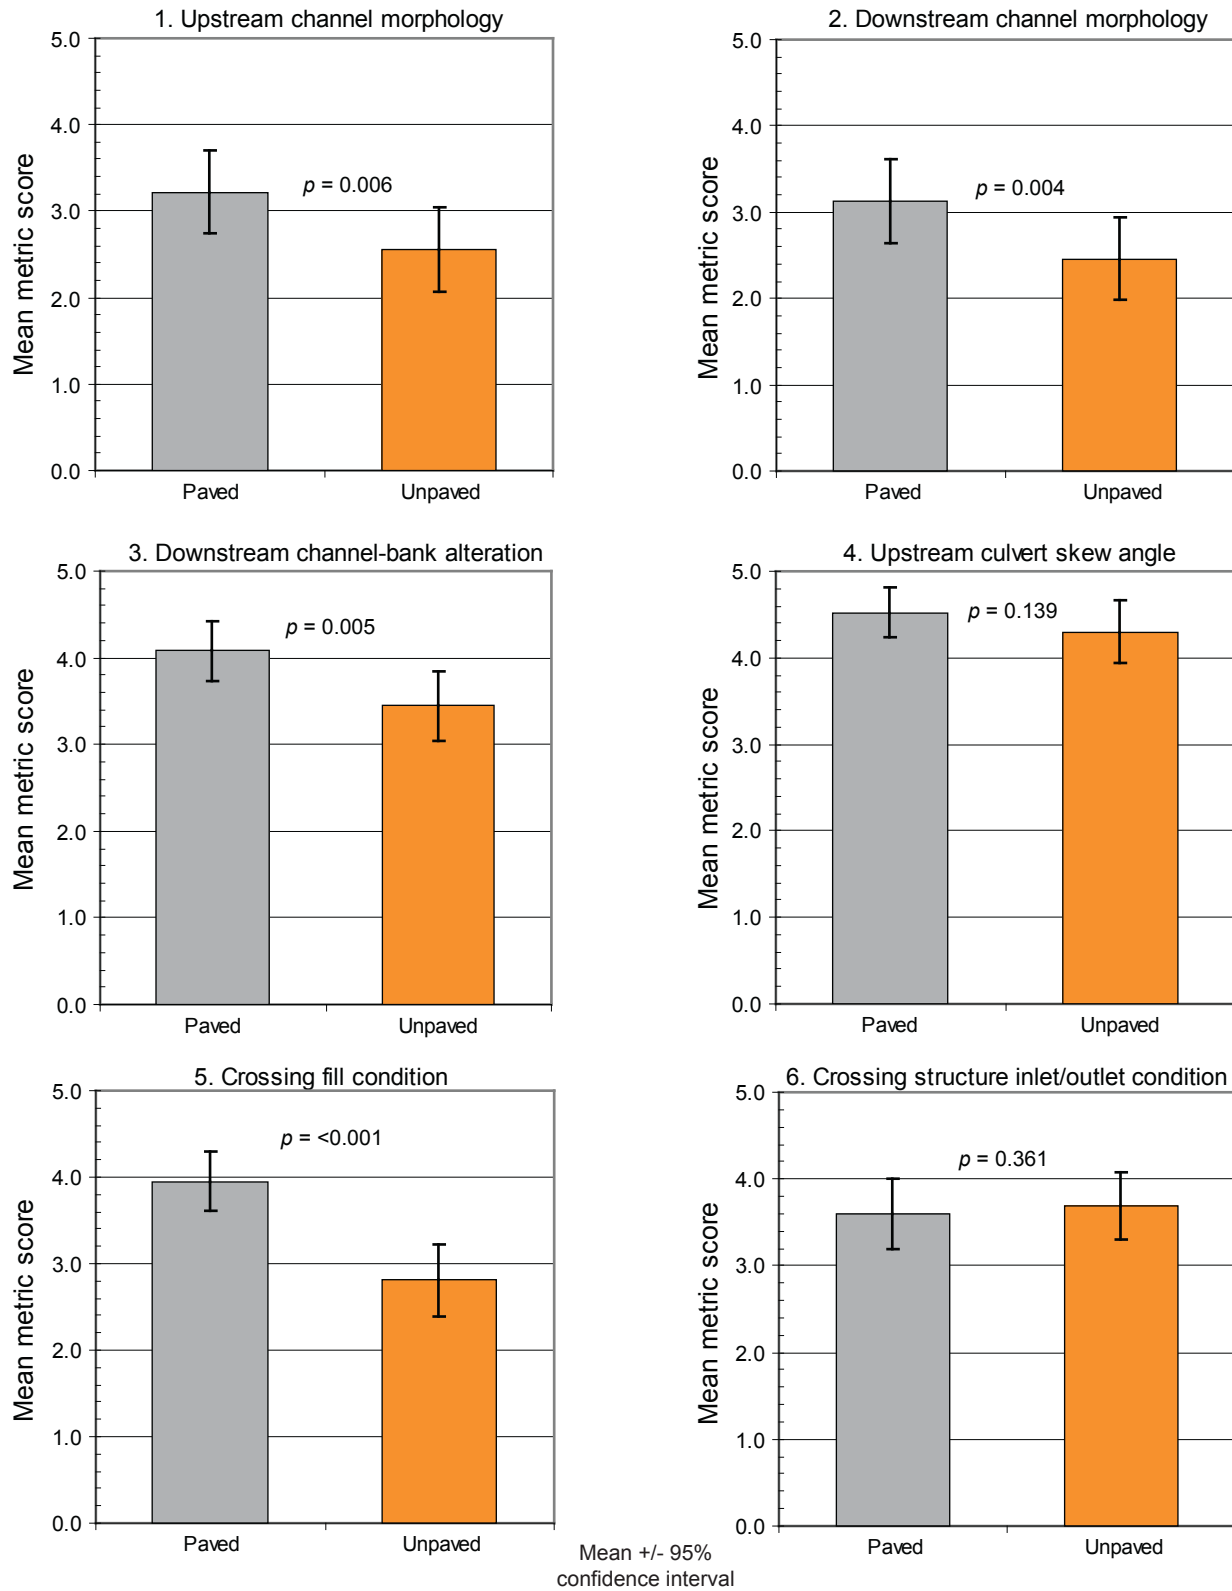
Figure 9. Comparison of metric scores between paved and unpaved roads for metrics 1-6 of the sedimentation risk index.

Unpaved roads generally presented a higher risk of instream sedimentation effects compared to paved roads (figs. 9, 10). The unpaved road prism was generally composed predominantly of native aggregate (gravel) mixed with some sand, which in most instances was a stable paving material with less tendency to migrate into streams (compared to roads and crossings dominated by a sand or sandy loam prism). Sedimentation issues identified for unpaved roads were related to the engineered ditches and their outlets to the stream and the poor condition of the bridge fill material. Crossing fill material that was not properly stabilized was a significant source of sediment at several sites, bare soil and/or unprotected ditches were also sources of sediment in addition to that eroded from poorly constructed/bare soil ditch outlets.

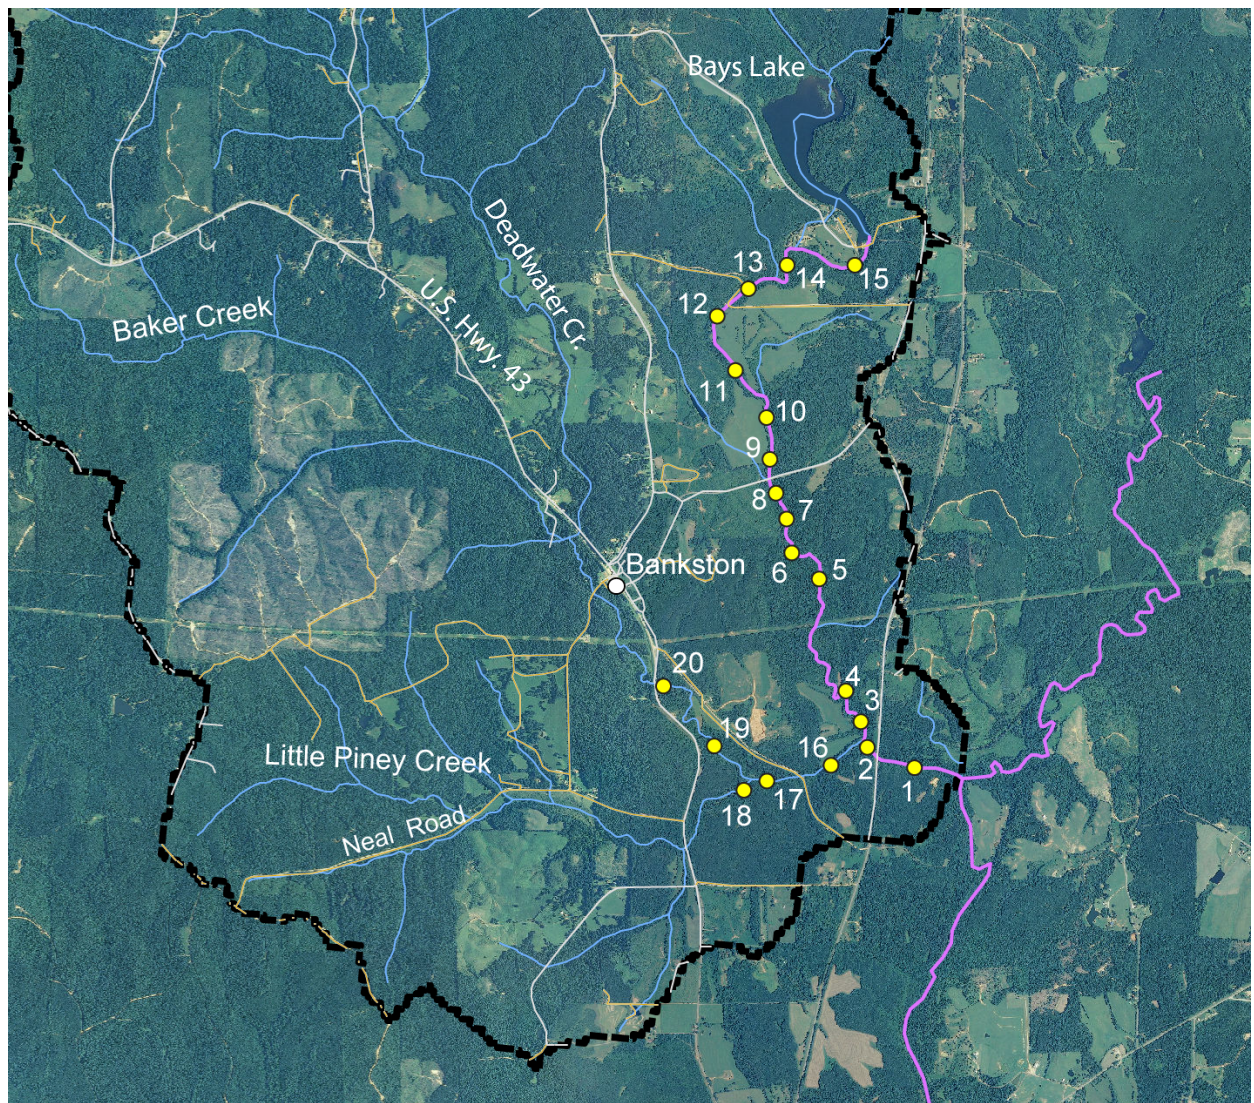
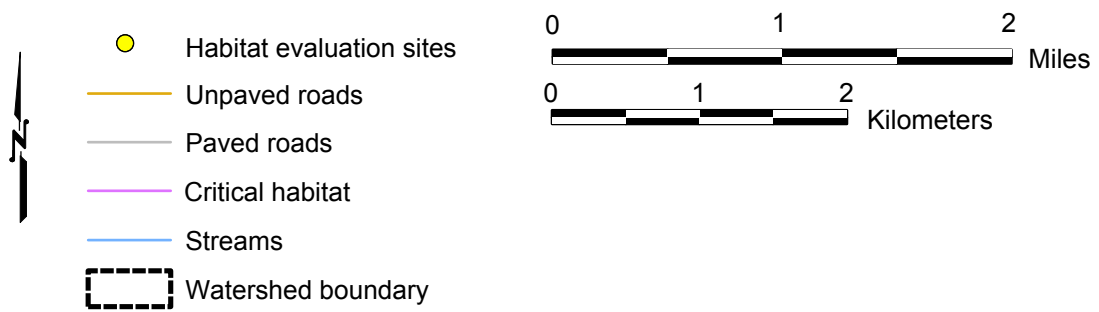
Figure 12. Habitat threat severity assessment sites in the Clear Creek watershed.

Twenty sites were evaluated for habitat threat severity in Clear and Deadwater Creeks (table 5, fig. 12, appendix B) in the upper reaches of the North River. Eleven of these sites ranked as low risk, eight as moderate risk, and one site ranked as high risk (table 6). The high risk site was located just downstream of the Bays Lake dam and was impaired for several reasons: fish passage blocked, presence of shoring structures along banks, and eroded banks due to the effects of flood waters over the spillway

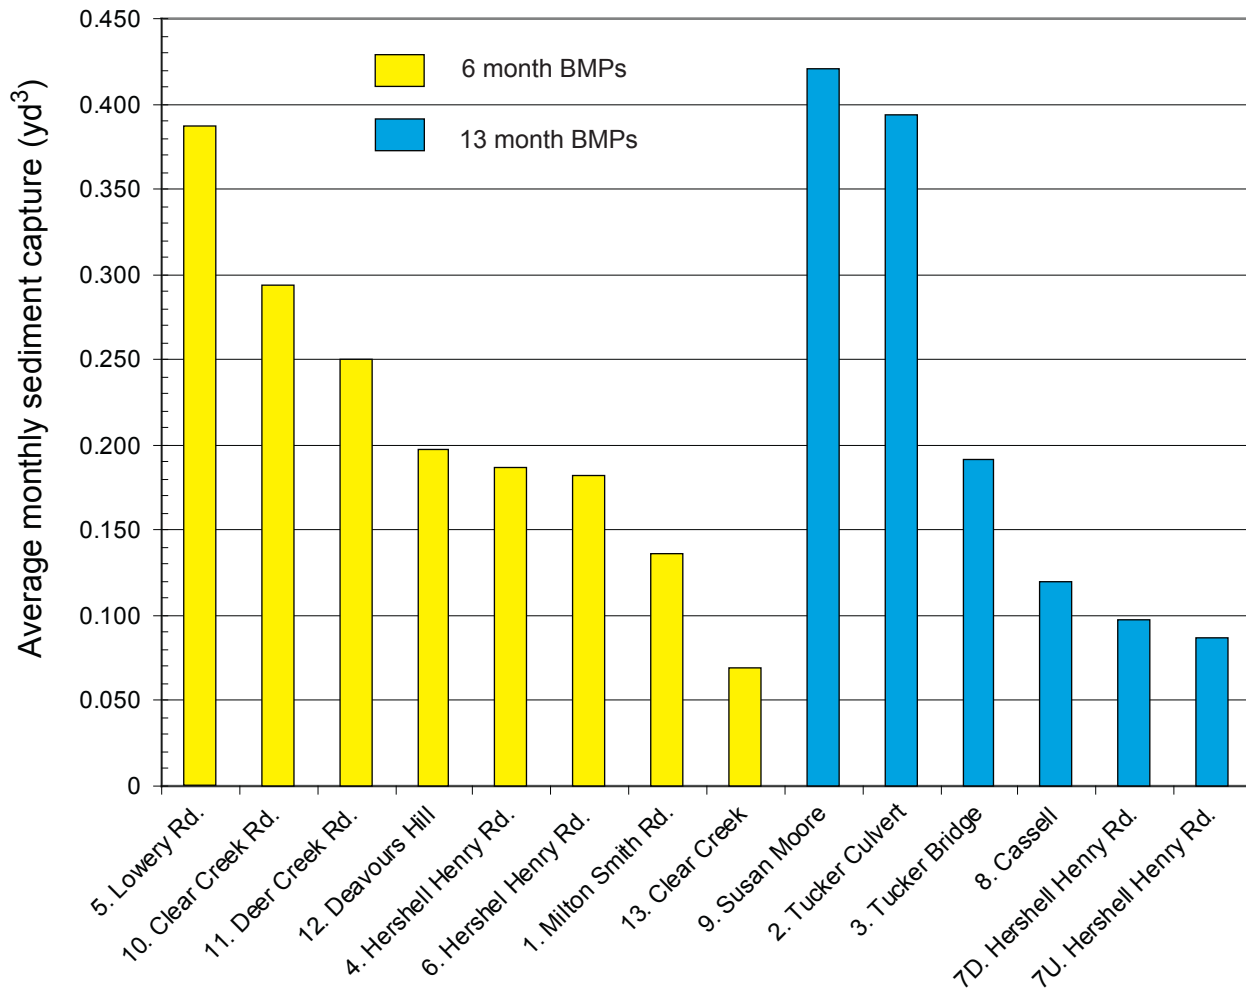
Figure 14. Average monthly sediment capture for control practices of 6-month and 13-month duration in the Clear Creek watershed, Fayette County.

capacity to capture much larger volumes of sediment. The long-term capture rate statistics are not available for these basins, but from November 2012 through December 2012 they captured an estimated 70 tons of sediment.
