High Definition Stream Surveys of Choccolocco and Cheaha Creeks, AL 2015

February 2016

Brett Connell and James Parham, Ph.D.

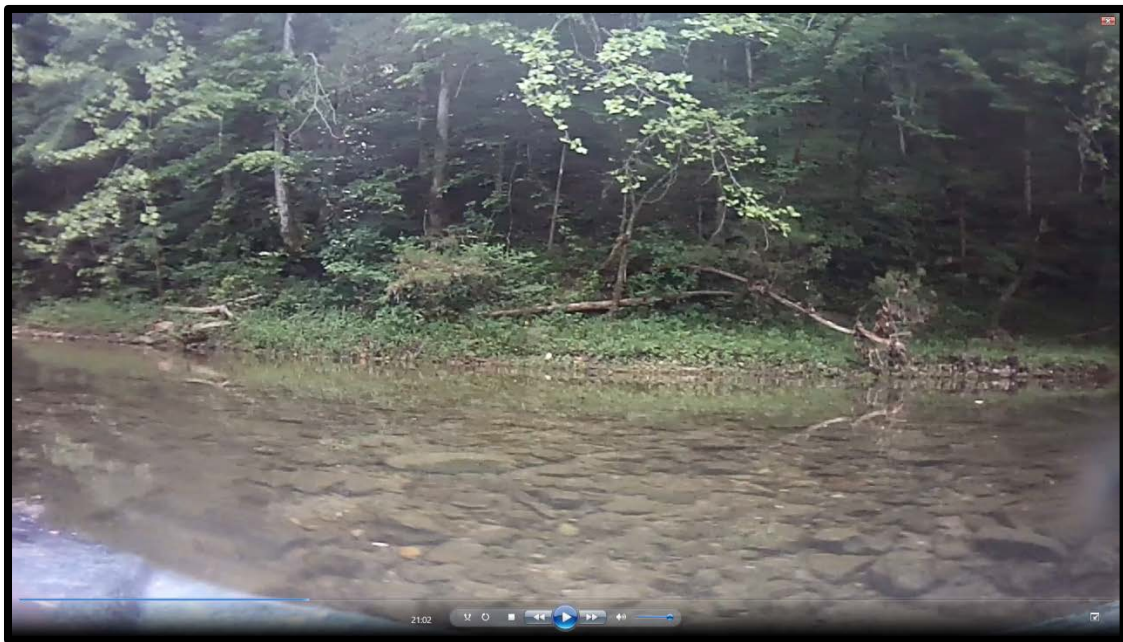
Figure 3: Level 1, Optimal Condition: Banks currently in optimal condition with excellent surface protection and low erosion potential. Includes stabilized areas such as bedrock outcroppings, heavily wooded areas, banks with low slopes and with good access to flood plain.

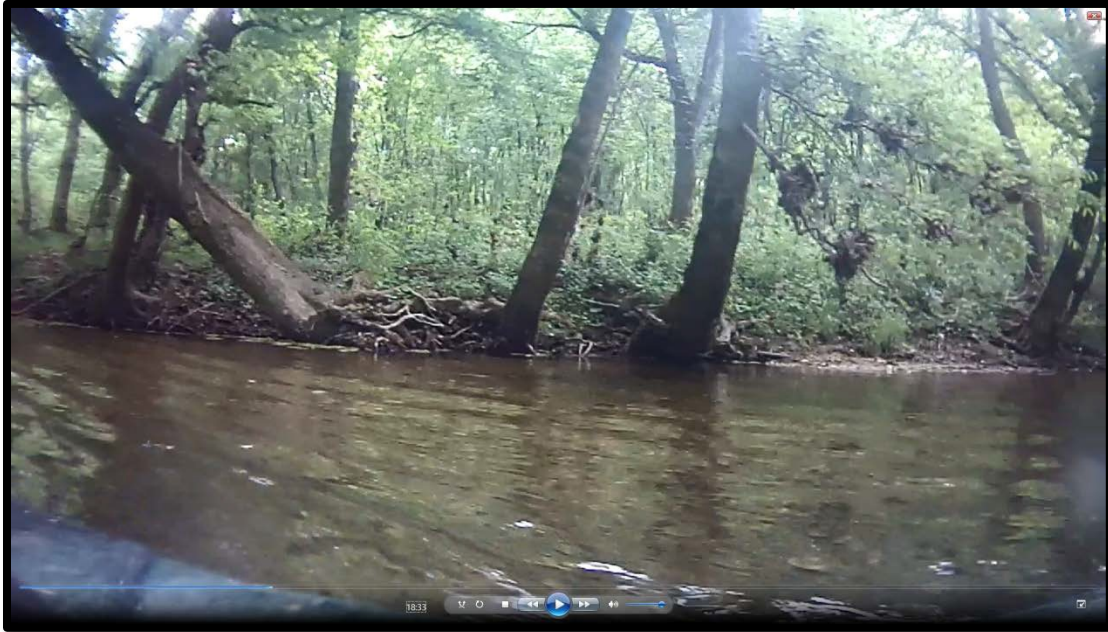
Figure 4: Level 2, Good Condition: Banks currently in good condition with minor impacts present. Includes heavily forested areas with moderate bank angles and adequate access to flood plains.

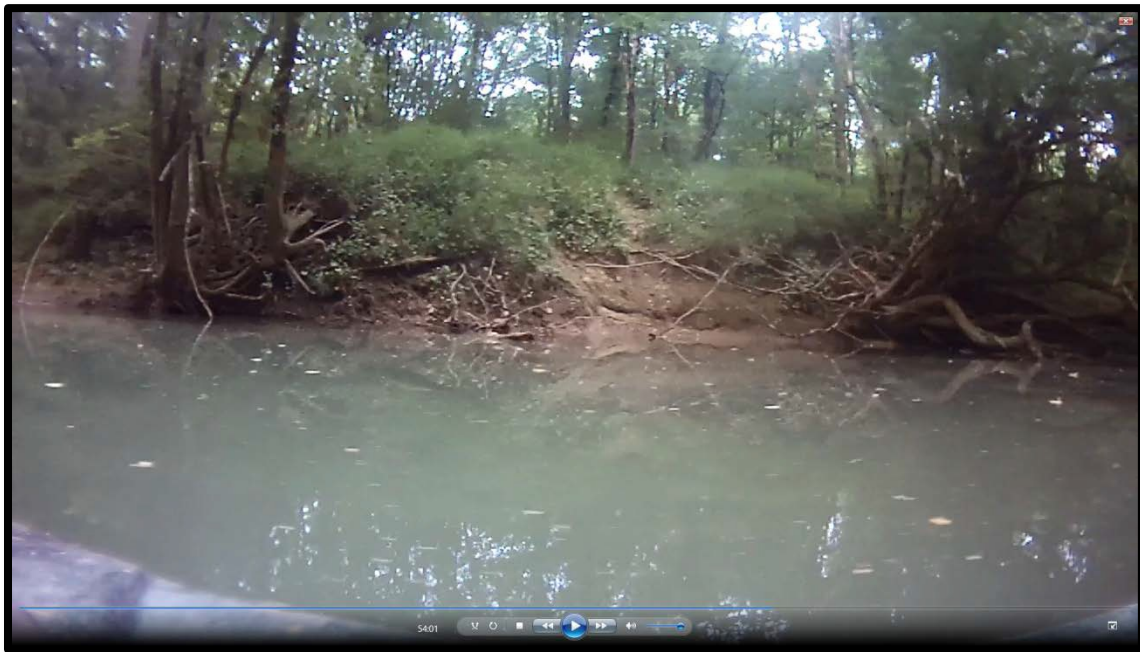
Figure 5: Level 3, Fair Condition: Banks showing moderate erosion impact with limited access to flood plain and variable surface protection. Potential impacts affecting water quality and aquatic habitat.

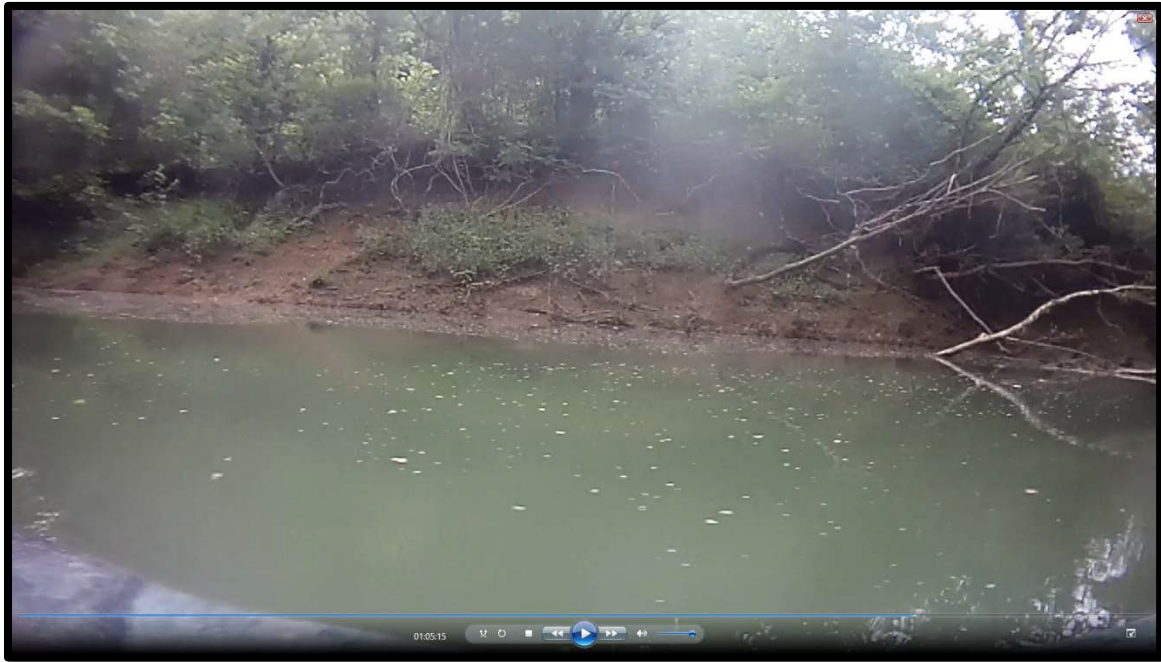
Figure 6: Level 4, Poor Condition: Banks with high erosion potential consisting of few trees and grass. Obvious impacts from cattle, agriculture, industry, with minimal connectivity to the flood plain. Source of negative impacts to water quality and aquatic habitat.

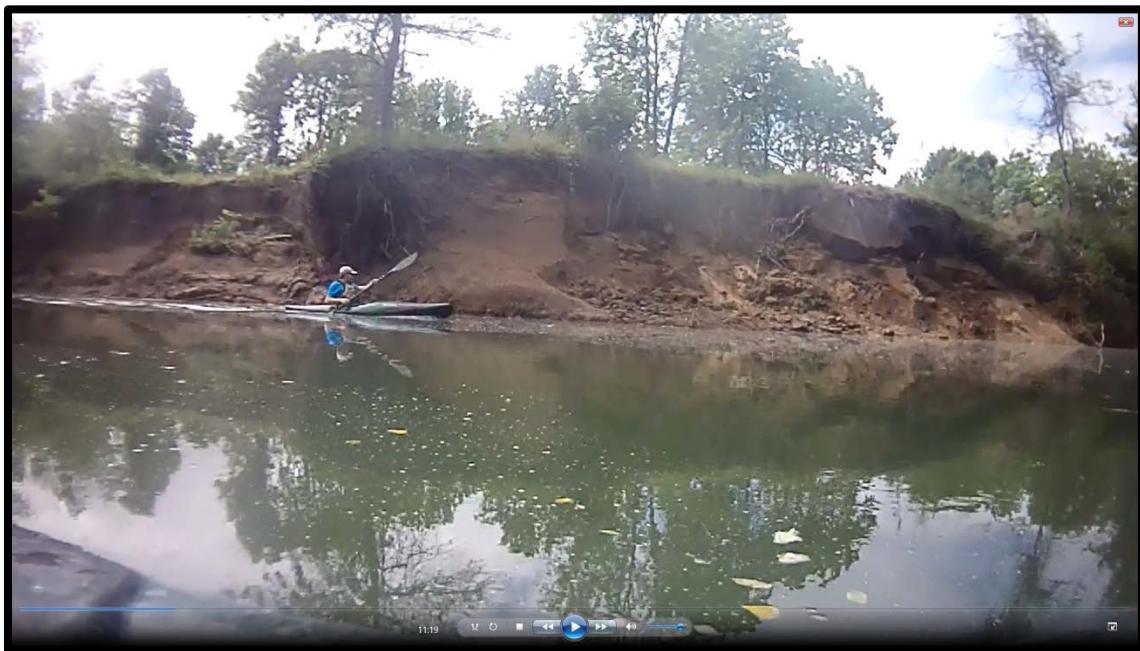
Figure 7: Level 5, Very Poor Condition: Banks with the highest erosion potential and steep bank angles. Evidence of active bank failure, with very little stabilization from vegetation. Obvious impacts from cattle, agriculture, and industry with no connectivity to flood plain. Contribution of sediment is very high in these areas.

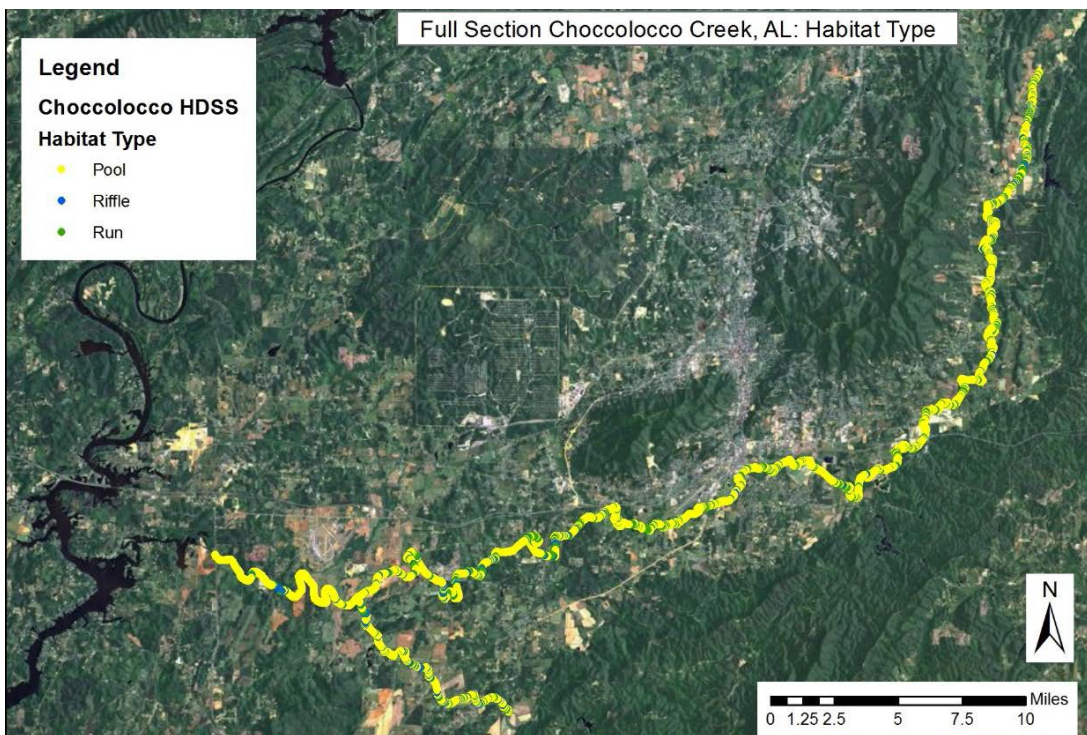
Figure 11: Choccolocco Creek Pool, Riffle, Run Locations.

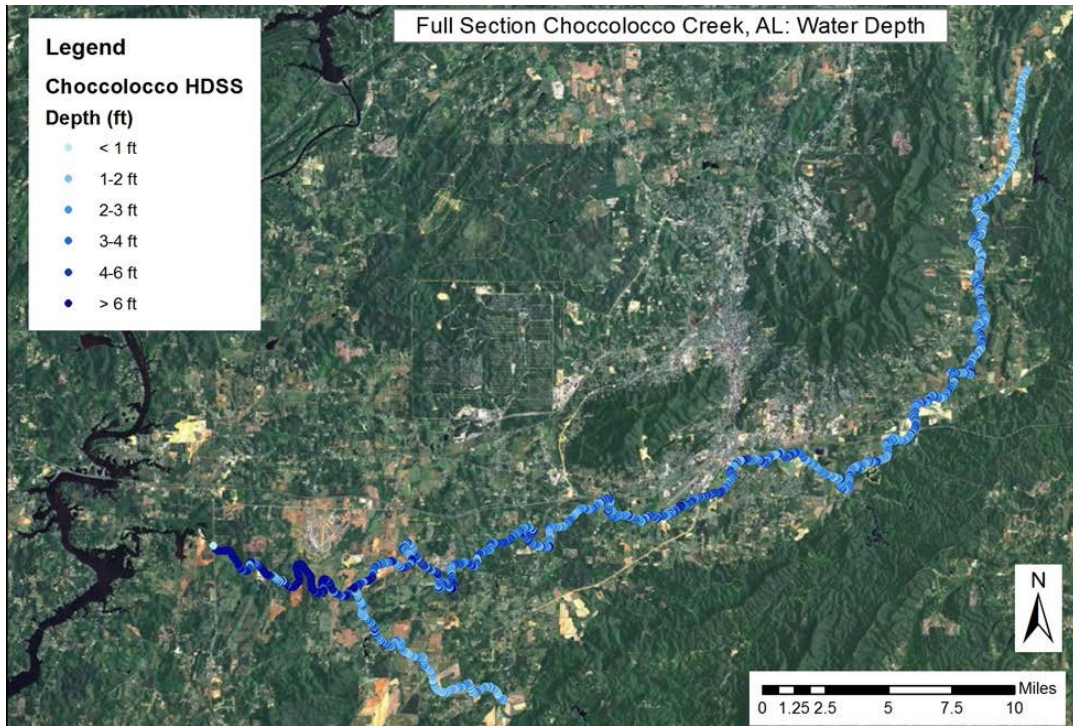
Figure 12: Choccolocco Creek Depth Measurements.

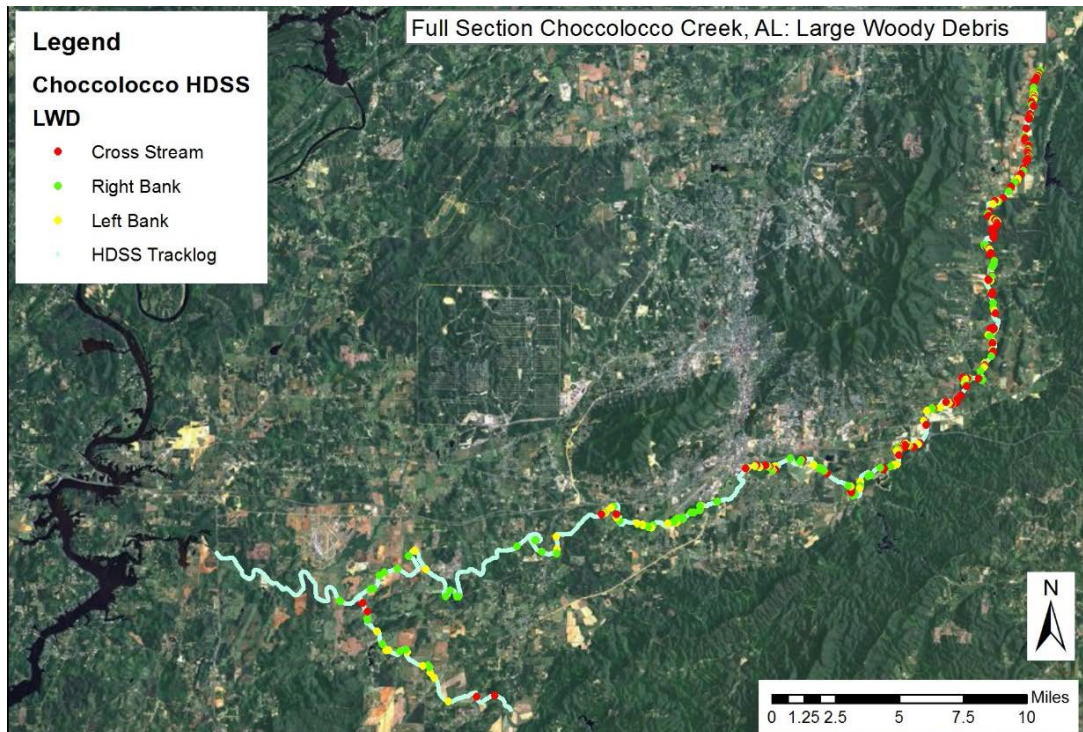
Figure 13: Choccolocco Creek Large Woody Debris locations.

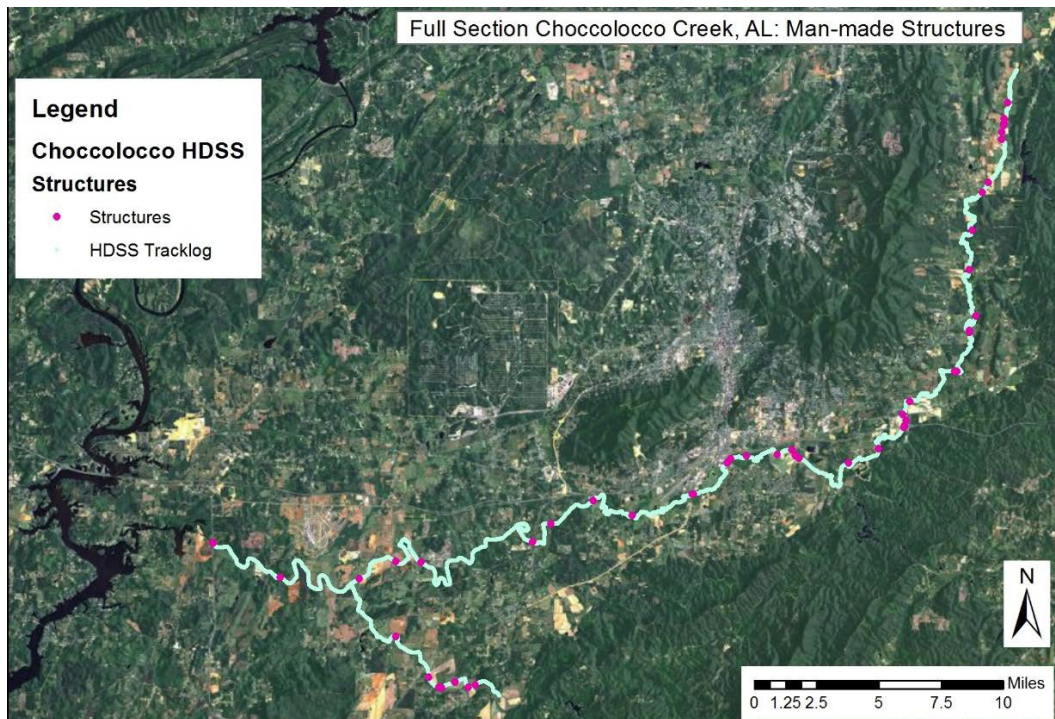
Figure 14: Choccolocco Creek Structure Locations.
